# Inspection Report

**Property Address:**  
17899 E. Princeton Pl.  
Aurora CO 80013

**Colorado Pro Inspect LLC**

<b>Date:</b> 10/29/2022	<b>Time:</b> 11:00 AM	<b>Report ID:</b> 22066
<b>Property:</b> 17899 E. Princeton Pl. Aurora CO 80013	<b>Customer:</b> Beverly Felipe	<b>Real Estate Professional:</b> Christy Holguin

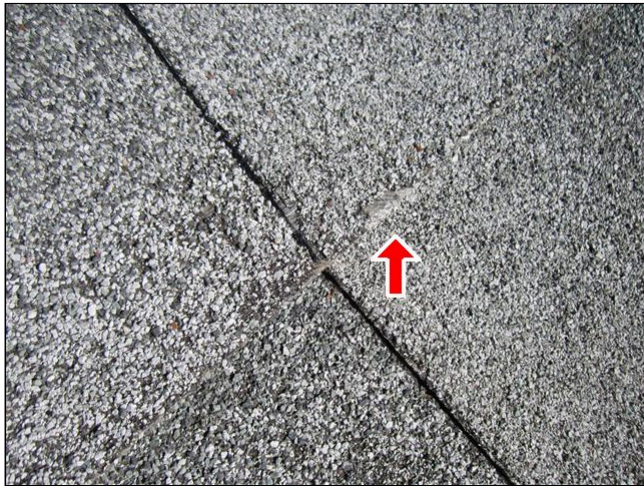
1.0 Item 1(Picture)

**1.0** The roof shingles are deteriorated/damaged/worn in areas. Repairs are needed. I recommend further evaluation and repair/certify for 5 years or replace as determined by a licensed roofer.

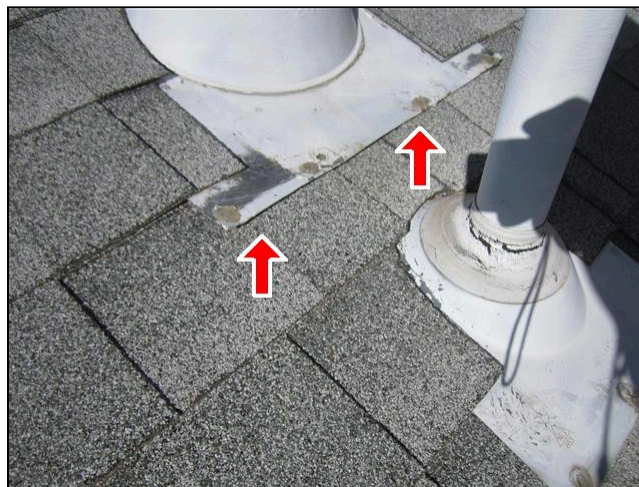
1.1 Item 1(Picture)

**1.1** The vent pipe flashing on the roof is loose. I recommend further evaluation and repair as needed by a qualified person/contractor.

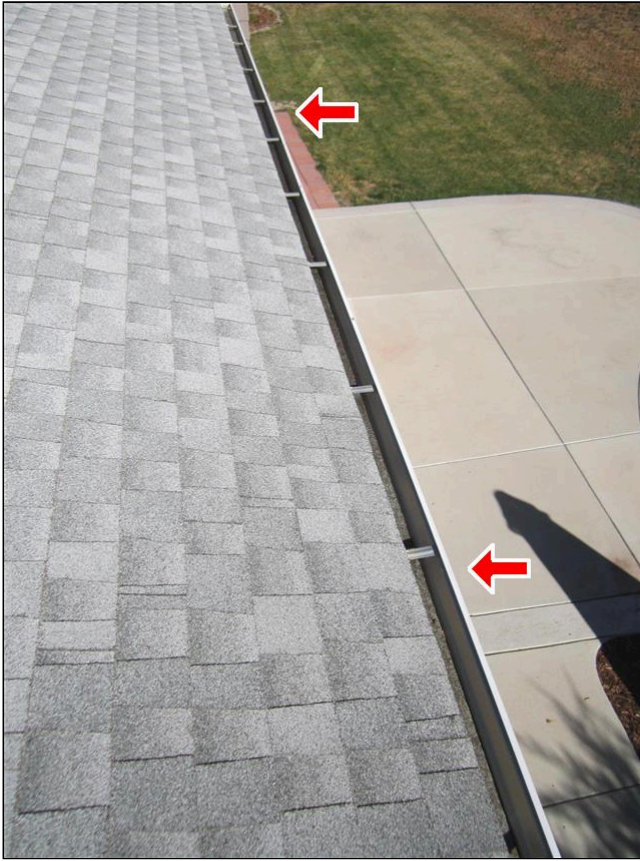
1.3 Item 1(Picture)

🏠 1.3 The gutters are full of debris in areas and need to be cleaned. The debris in gutters can also conceal rust, deterioration or leaks that are not visible until cleaned, and I am unable to determine if such conditions exist. I recommend further evaluation and repair/clean as needed by a qualified person.

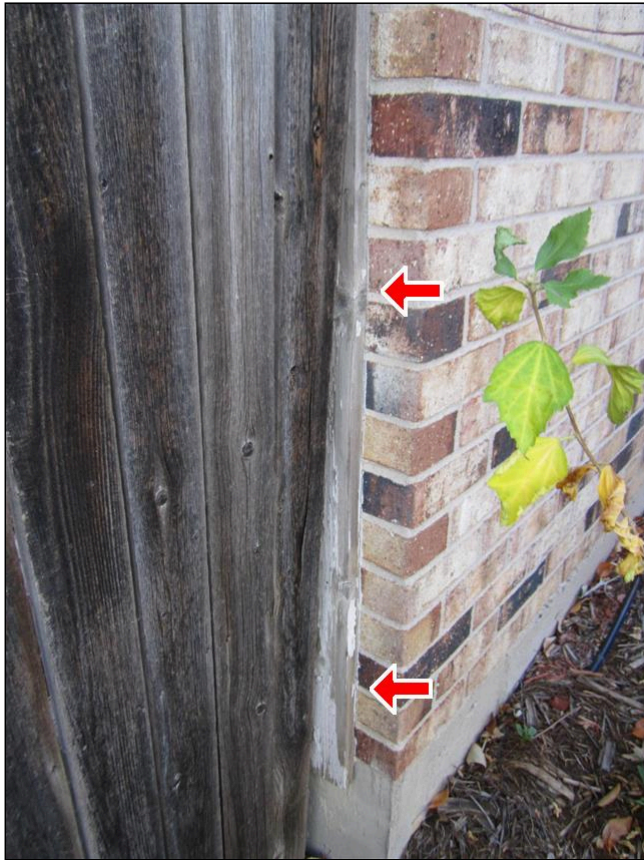
2.0 Item 1(Picture)

🏠 2.0 (1) The wood trim/siding at the exterior is deteriorated/damaged and worn in areas. This is a maintenance issue. I recommend further evaluation/continued monitoring and repair as needed by a qualified person/contractor.

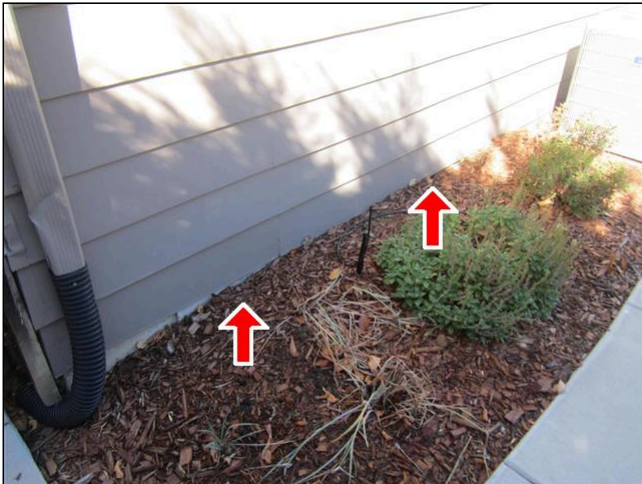
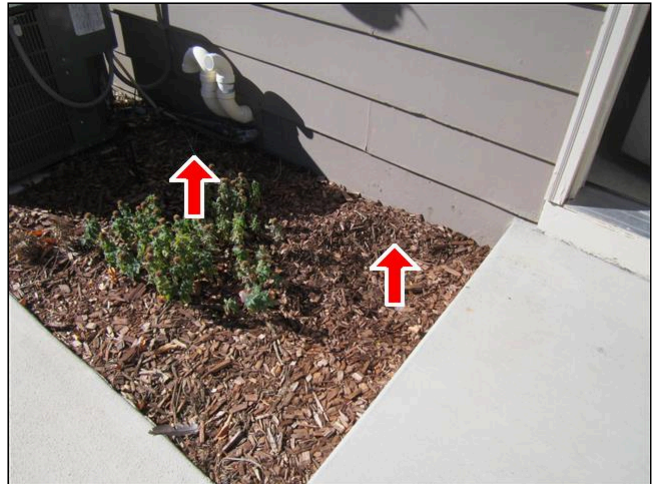
🏠 2.0 (2) The siding at the exterior is in contact with ground in areas. Ground clearance is recommended to prevent possible water infiltration, deterioration and mold growth. A qualified person should repair as needed.

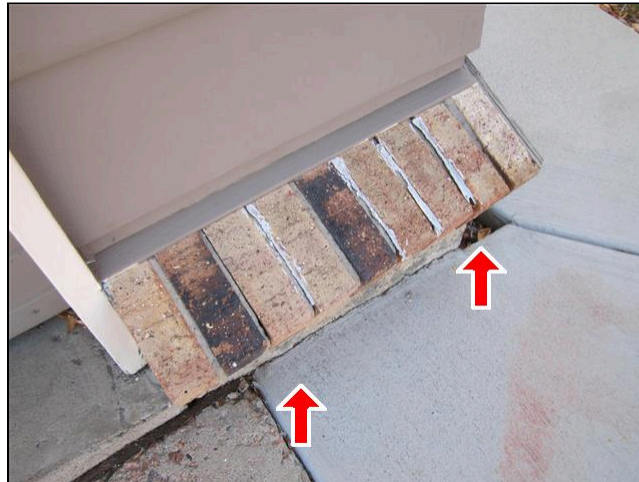
2.0 Item 7(Picture)

🏠 2.0 (3) There are several bricks loose at the right side of the garage. Repairs are needed. I recommend further evaluation and repair as needed by a qualified contractor.

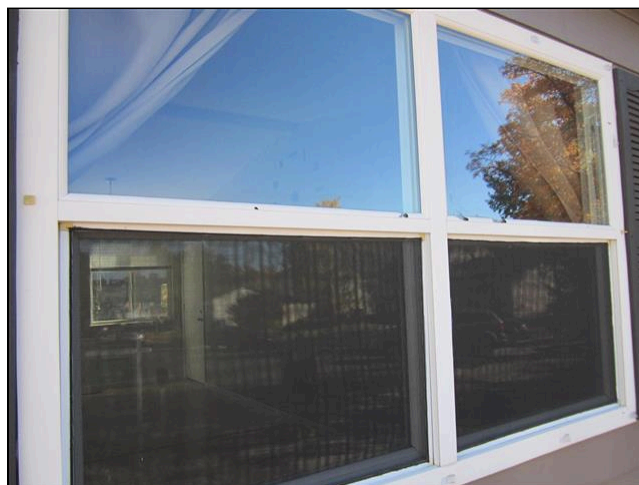
2.2 Item 1(Picture)

🏠 2.2 (1) The window frame's are damaged at front of home. This is for your information. I recommend continued monitoring and repair/replace as needed.

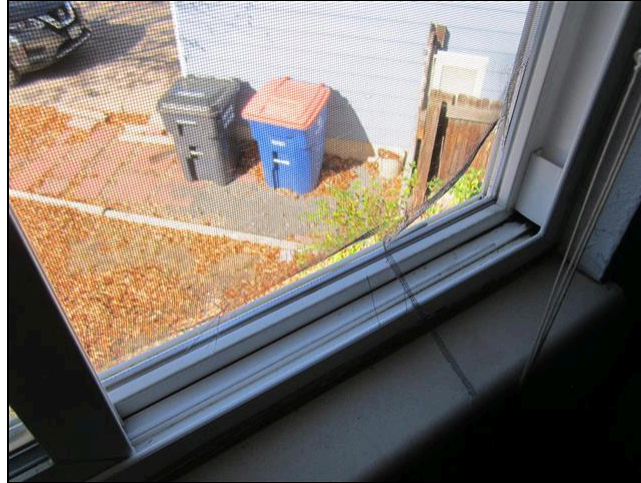
2.2 Item 2(Picture)

🏠 2.2 (2) The window screens are deteriorated/damaged/worn or missing at several windows. This is for your information. I recommend repair as needed/desired.

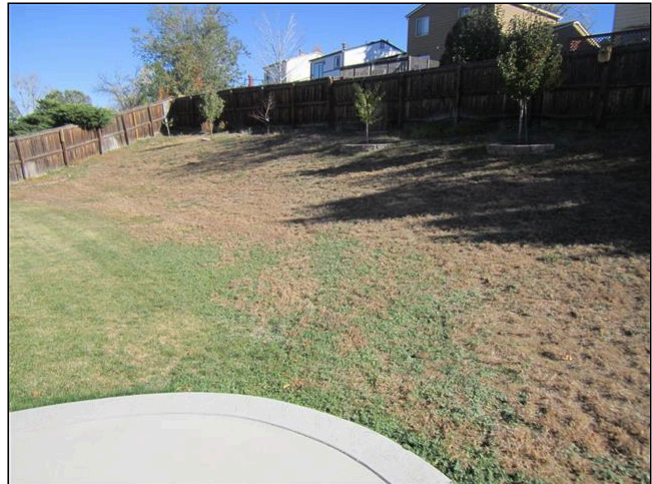
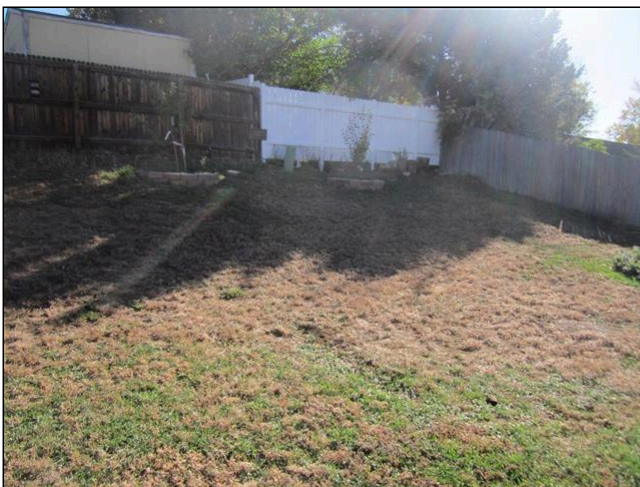
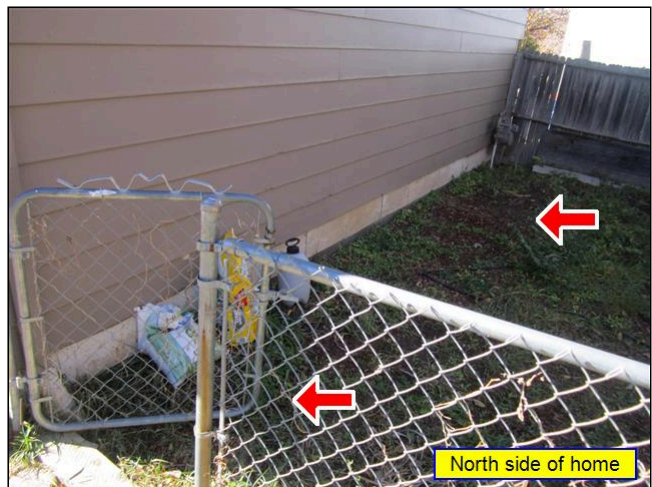
🏠 2.4 (1) There is a negative slope at the front, rear and sides of home and can cause or contribute to water intrusion or deterioration. I recommend correcting landscape to drain water away from home as needed.

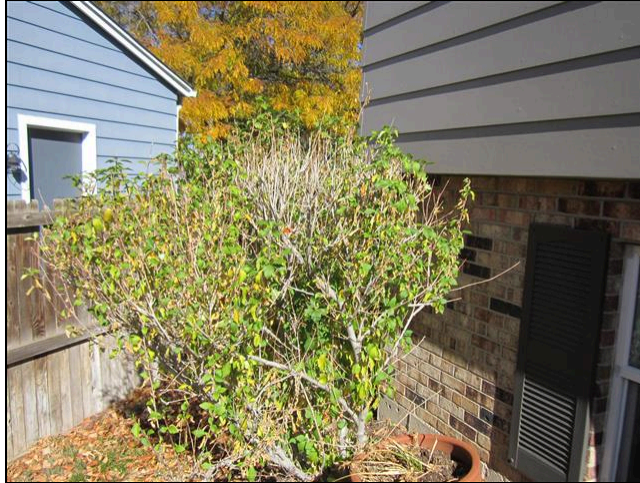
2.4 Item 5(Picture)

🏠 2.4 (2) The tree limbs and bushes that are in contact with roof or hanging near roof and house should be trimmed or removed. I recommend further evaluation and repair as needed by a qualified person.

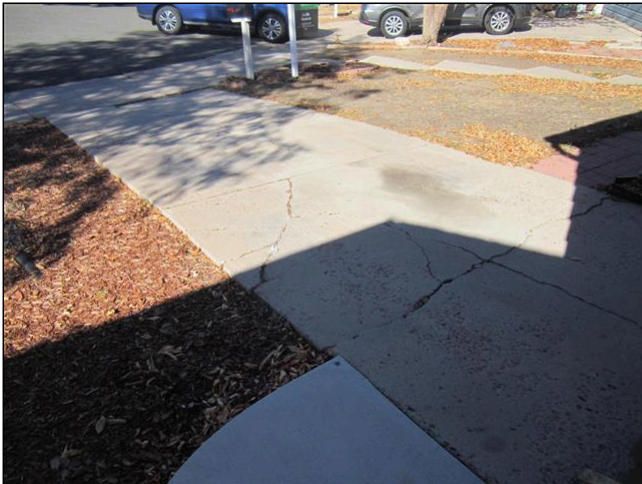
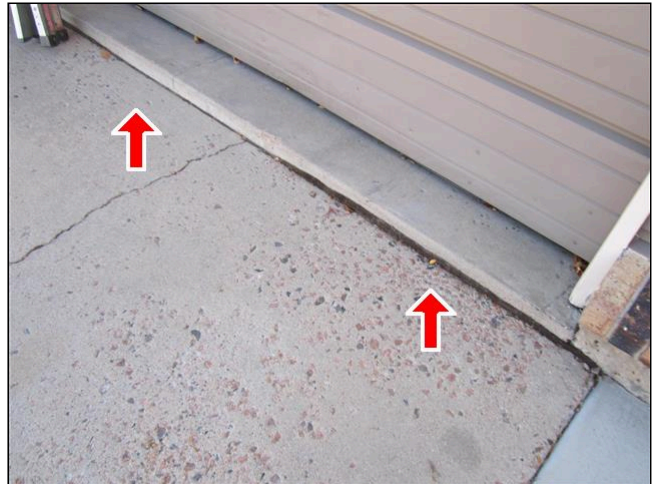
🏠 2.4 (3) The concrete drive at the front of home has settled, has settlement cracks and is damaged/cracked. Repairs are needed. I recommend further evaluation and repair as needed by a qualified contractor.

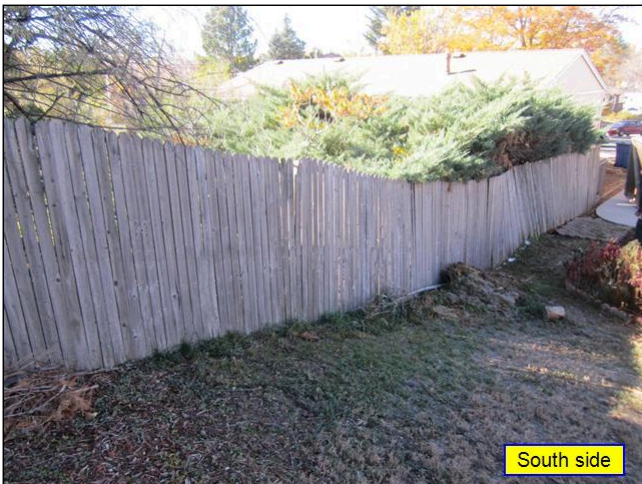
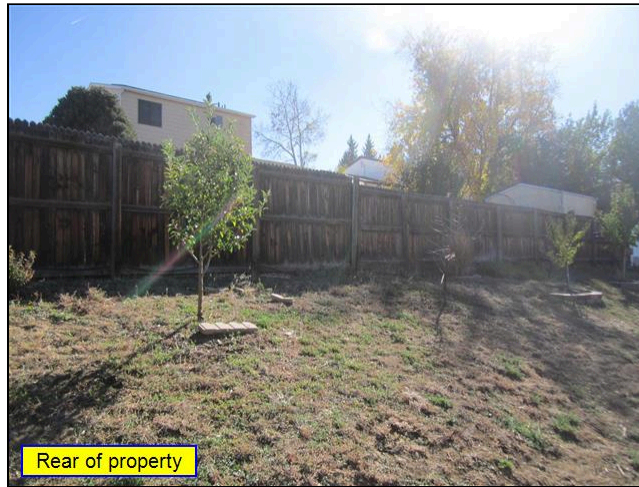
🏠 2.6 The fence is damaged, worn and loose in areas. Repairs are needed. I recommend further evaluation and repair as needed by a qualified person.

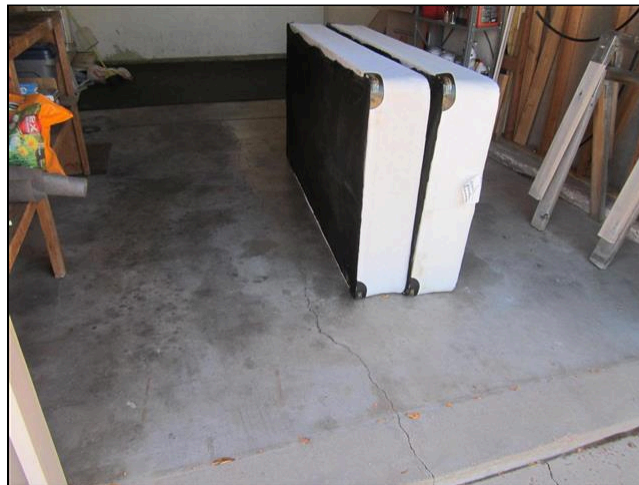
3.2 Item 1(Picture)

**3.2** The concrete floor of garage has settled/heaved and is cracked in areas. This is for your information. I recommend continued monitoring and repair as needed.

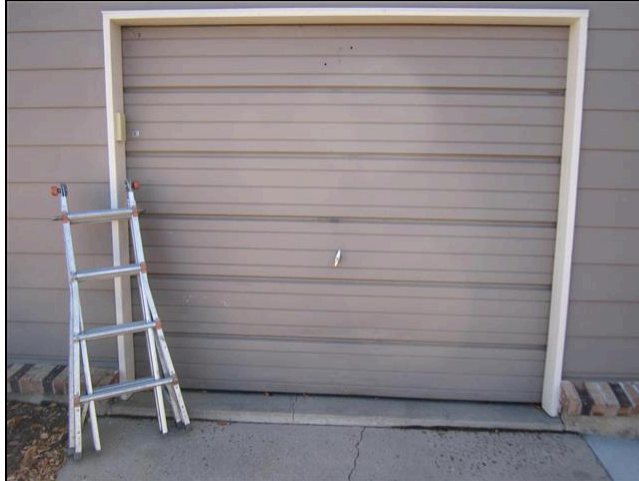
3.3 Item 1(Picture)

**3.3** The garage door at the front of home is deteriorated/damaged and worn in areas. This is for your information. I recommend continued monitoring and repair as needed.

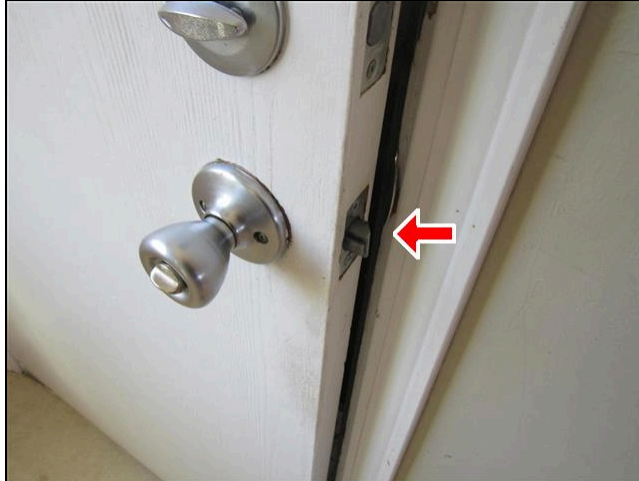
3.4 Item 2(Picture)

**3.4** (2) The garage entry door lock does not latch properly when closed. I recommend further evaluation and repair as needed by a qualified person.

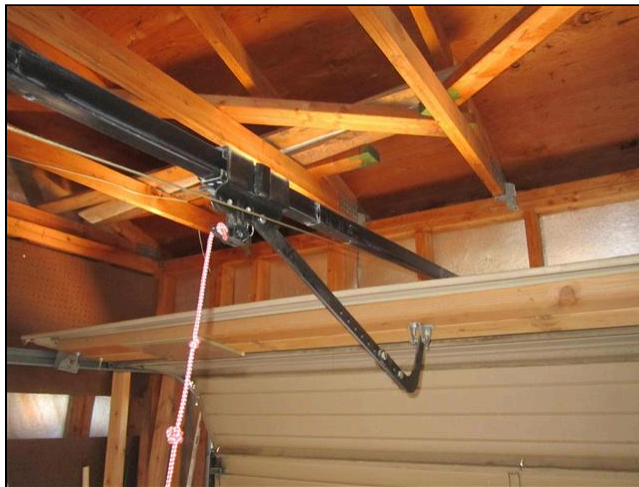
3.5 Item 1(Picture)

**3.5** The automatic opener for garage door is noisy during operation (chain rubs on the door) and it appears the door is only being lifted by the automatic opener (garage door springs appear disconnected). This is for your information. I recommend continued monitoring and repair as needed.

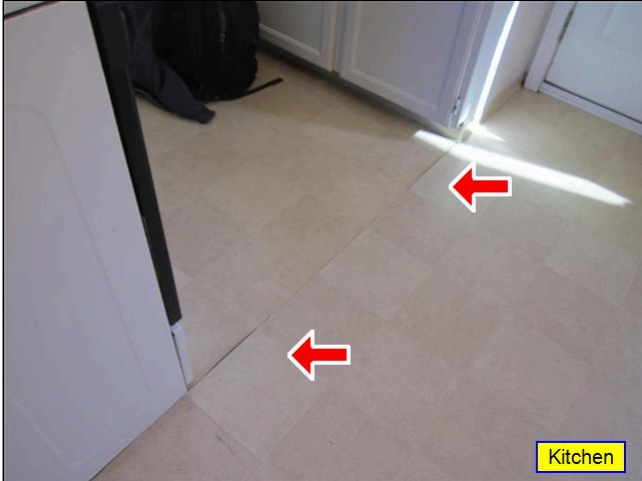
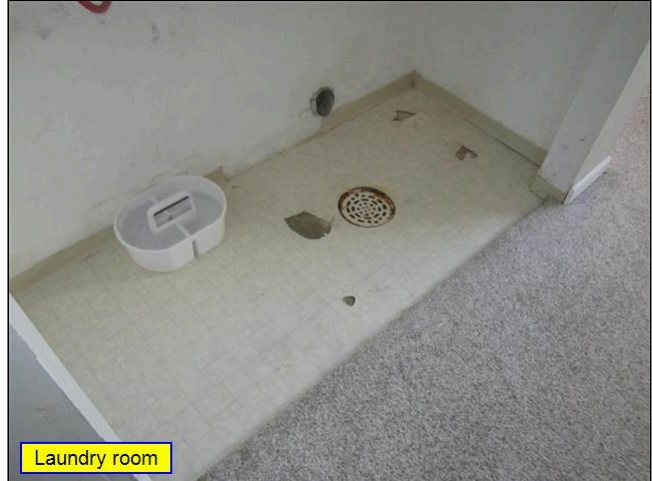
🏠 4.2 (1) There are multiple locations throughout the home where the floor covering is deteriorated and worn. I recommend repair/replace as needed/desired.

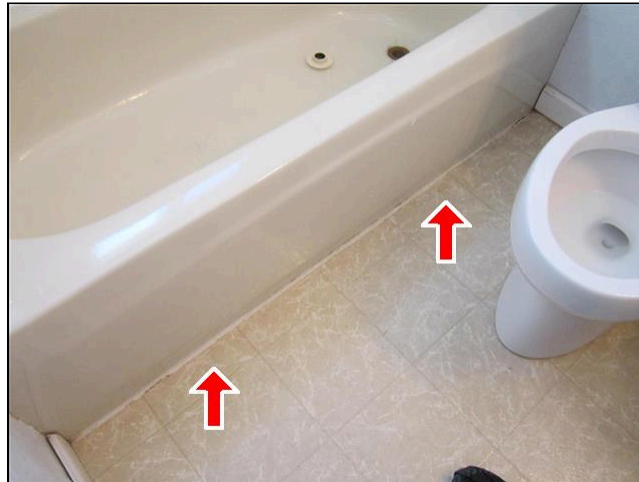
4.2 Item 3(Picture)

🏠 4.2 (2) The vinyl floor is curling at the upstairs hall bath and has deteriorated/worn caulking along the tub/shower. I recommend repair as needed by a qualified person.

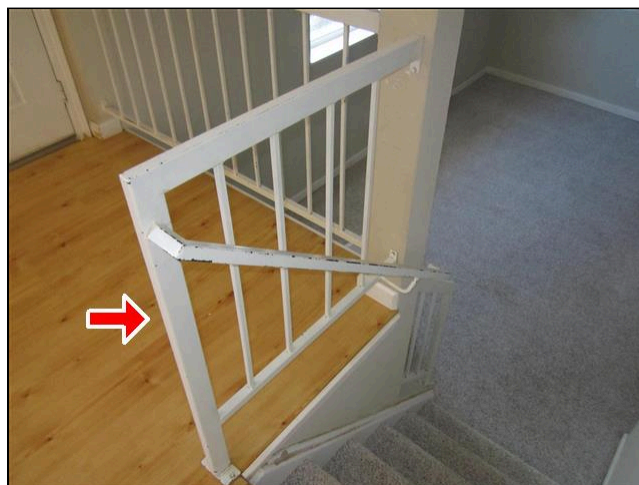
4.3 Item 1(Picture)

🏠 4.3 (1) The hand/guard rail for the stairs to lower level is loose. A repair is needed. I recommend further evaluation and repair as needed by a qualified person/contractor.

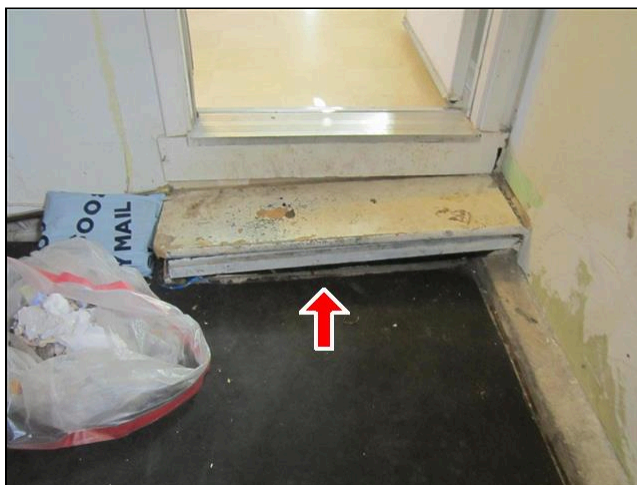
4.3 Item 3(Picture)

🏠 4.3 (3) The garage door step is uneven. This is for your information. I recommend repair as needed.

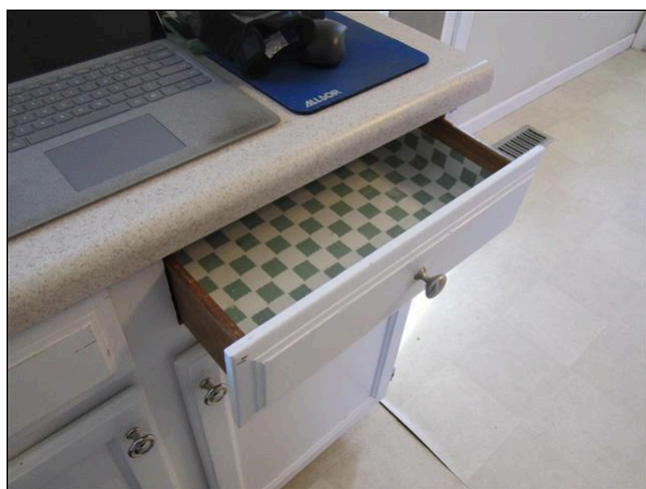
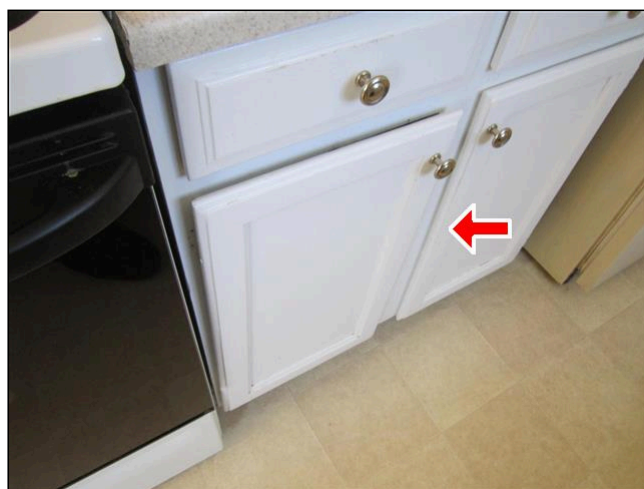
4.4 Item 1(Picture)

🏠 4.4 There are several cabinet doors/drawers that are damaged/deteriorated and do not close and open properly at the kitchen. I recommend repair as needed

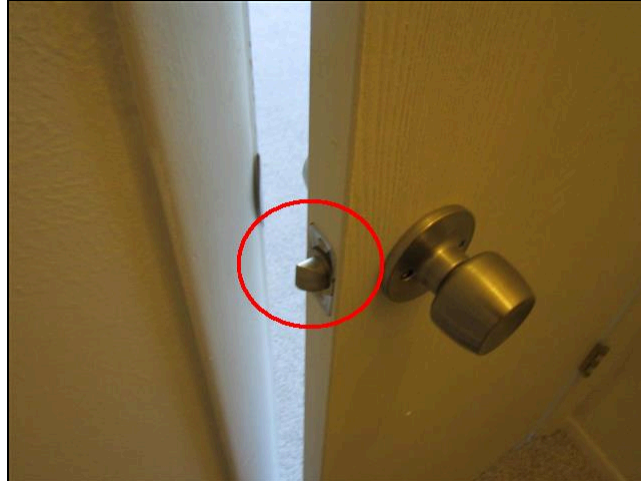
4.5 Item 1(Picture)

🏠 4.5 The upstairs bedroom closet door does not latch properly when closed (hardware is installed backwards). I recommend repair as needed.

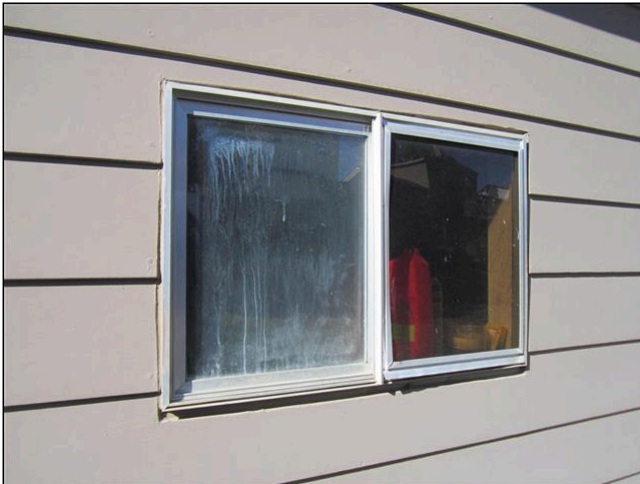
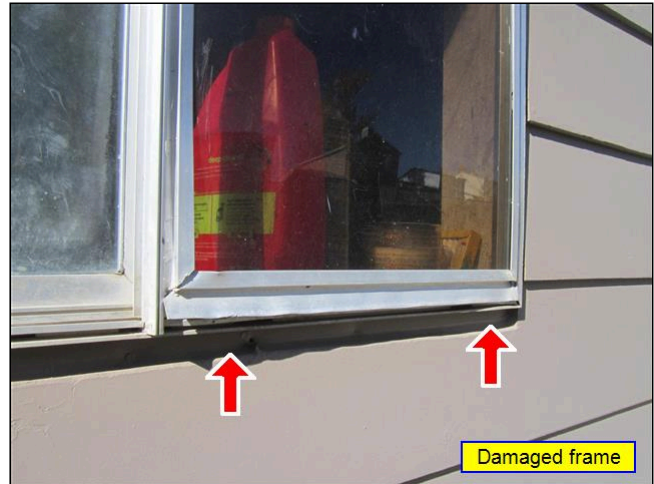
🏠 4.6 (1) One window is damaged/deteriorated and cloudy (lost seal) at the garage. Repairs are needed. A qualified person/contractor should evaluate and repair as needed.

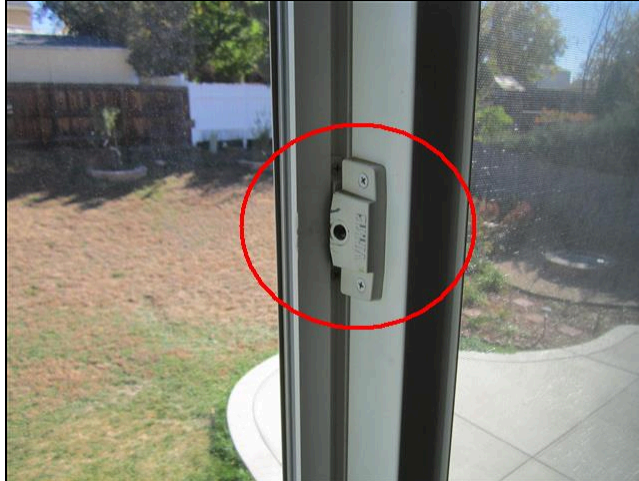
4.6 Item 4(Picture)

**4.6** (2) One window is damaged at it's lock hardware at the upstairs bedroom. A repair is needed. A qualified person should repair as needed.

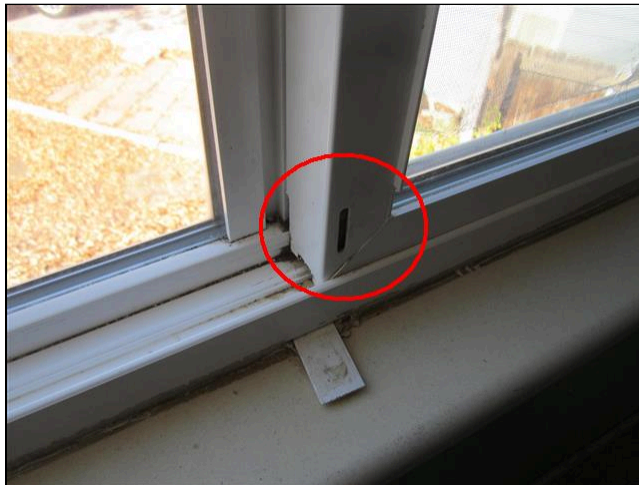
4.6 Item 5(Picture)

**4.6** (3) The lock hardware is missing at the window in the master bedroom. I recommend repair as needed.

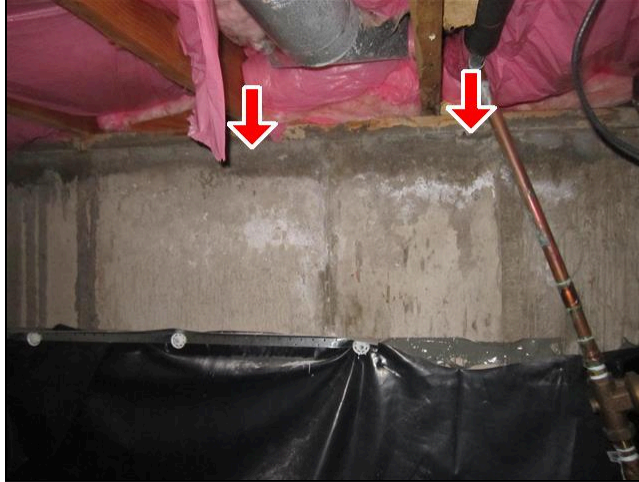
5.0 Item 1(Picture)

🏠 5.0 (2) White efflorescence (powder substance) on concrete wall indicates moisture is in contact with the masonry. This does not necessarily indicate that intrusion will occur. I recommend checking the gutters and the downspout drain lines for proper operation. Also, a water proofing paint could be applied to the interior side of the concrete if necessary. Efflorescence is found on many homes without water intrusion occurring inside the home. But, it should alert you to the possibility that future steps may be needed. I recommend continued monitoring and repair as needed.

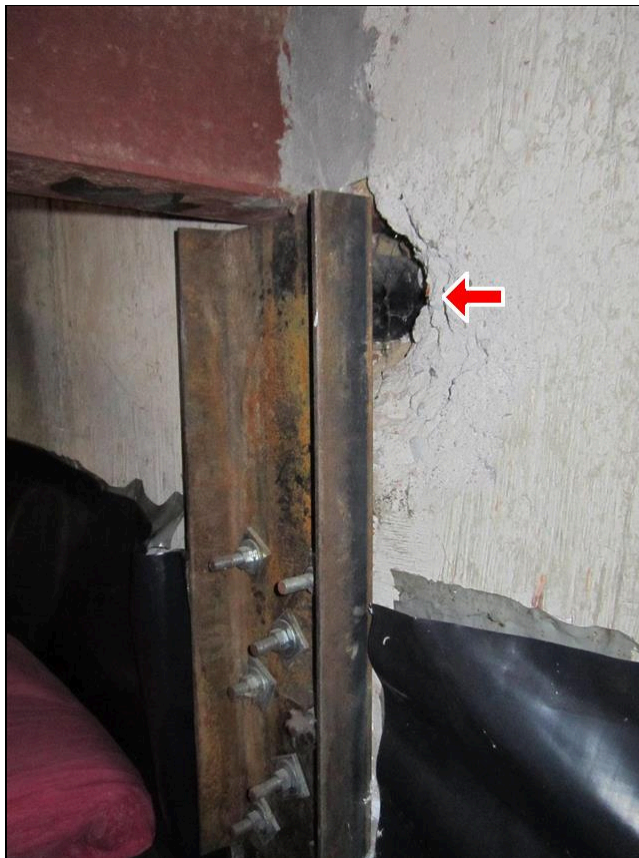
5.0 Item 2(Picture)

🏠 5.0 (3) The steel beam has been reinforced where it connects to the concrete foundation in the crawlspace. This is for your information. I recommend continued monitoring and repair if needed by a qualified contractor/engineer.

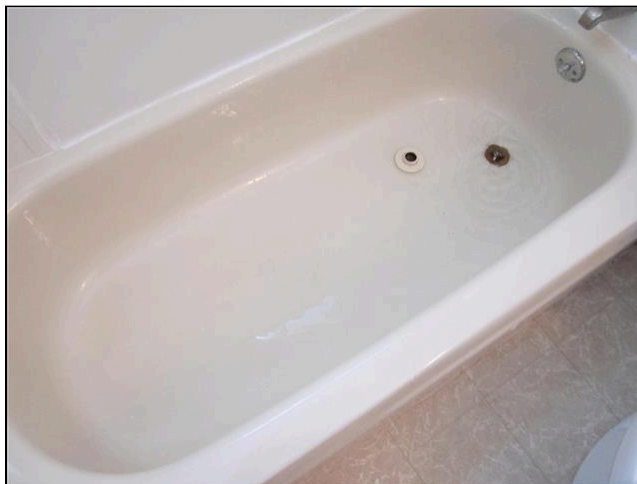
6.0 Item 1(Picture)

🏠 6.0 (3) The plumbing waste line drains slowly at the upstairs hall bath tub. A cause of a slow drain can range from a simple cleaning at stop valve or at the trap under tub. Sometimes the drain can be partially clogged down line. I am unable to determine the cause of the slow drain. A qualified person should evaluate and repair as needed.

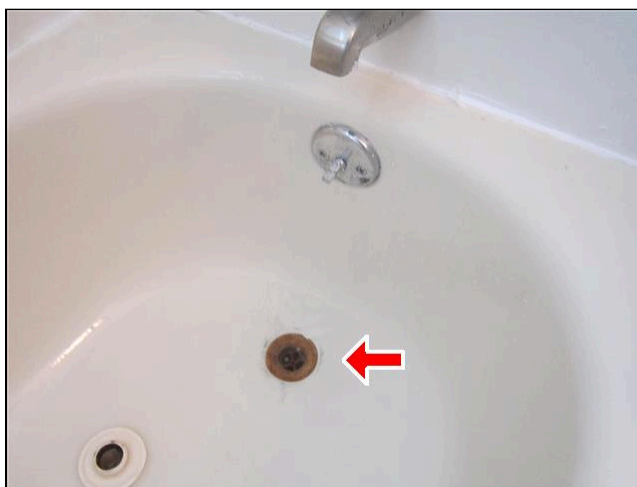
6.0 Item 2(Picture)

🏠 6.0 (4) The drain stopper at the upstairs hall bath tub is non functional. I recommend repair as needed by a qualified person.

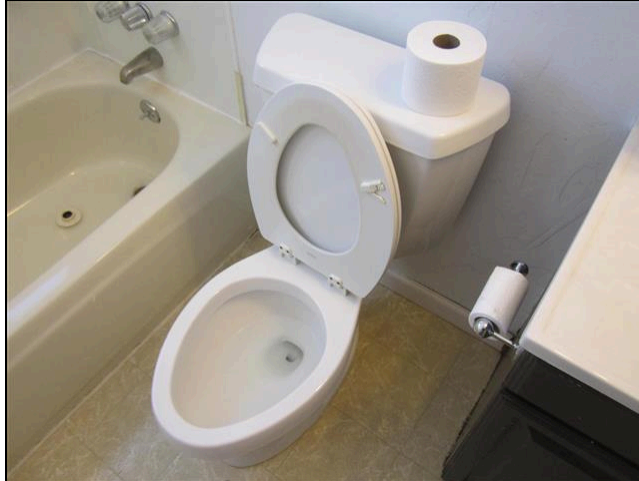
6.0 Item 3(Picture)

**6.0** (5) The toilet is loose at floor at the upstairs hall bath (appears minor). I recommend further evaluation and repair as needed by a qualified person/contractor.

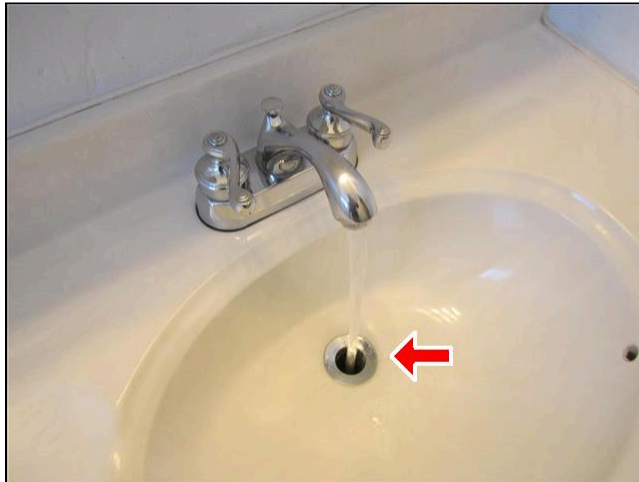
6.0 Item 4(Picture)

**6.0** (6) The drain stopper at the upstairs hall bath sink is missing and non functional. I recommend repair as needed by a qualified person.

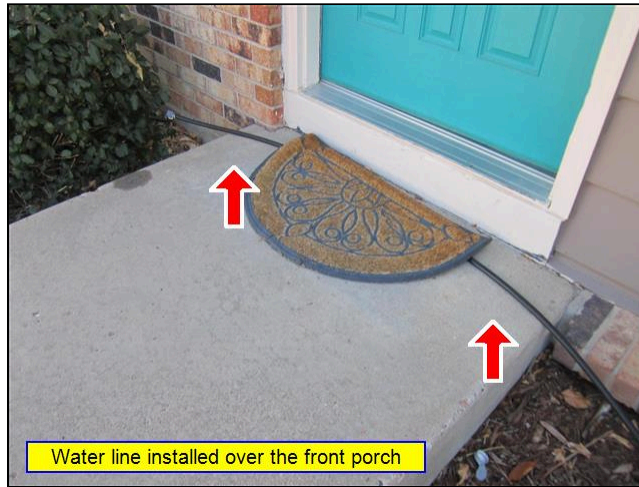
6.1 Item 1(Picture)

🏠 6.1 (2) The home sprinkler/drip system is installed improperly. the system requires hooking the water supply lines to the exterior faucet connections to operate and all of the water supply lines are installed above grade and susceptible to freezing. Repairs are needed. I recommend further evaluation and repair as needed by a qualified contractor.

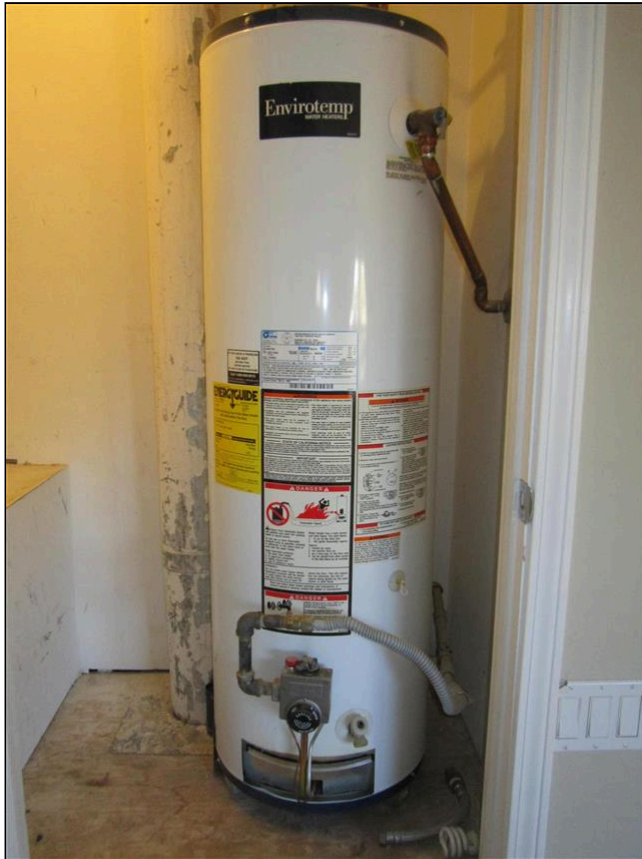
6.2 Item 1(Picture)

6.2 (2) The water heater is old (mfg 2003 - typical life is 10-12 yrs), deteriorated/worn and past the end of its life expectancy. No leaks at present, however it is my opinion a replacement unit is needed. I recommend further evaluation and repair/replace as recommended by a licensed plumber.

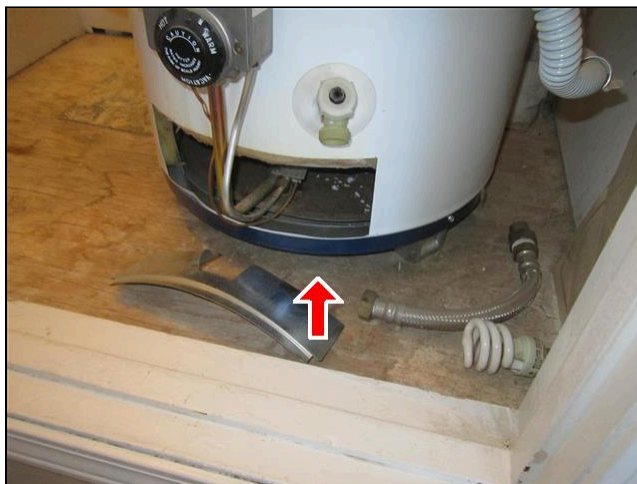
6.2 Item 4(Picture)

**6.2** (3) The water heater was not installed in a water drain/catch pan at the time of installation. This may help catch water if the unit starts to leak/fail. I recommend repair as needed by a qualified person/contractor.

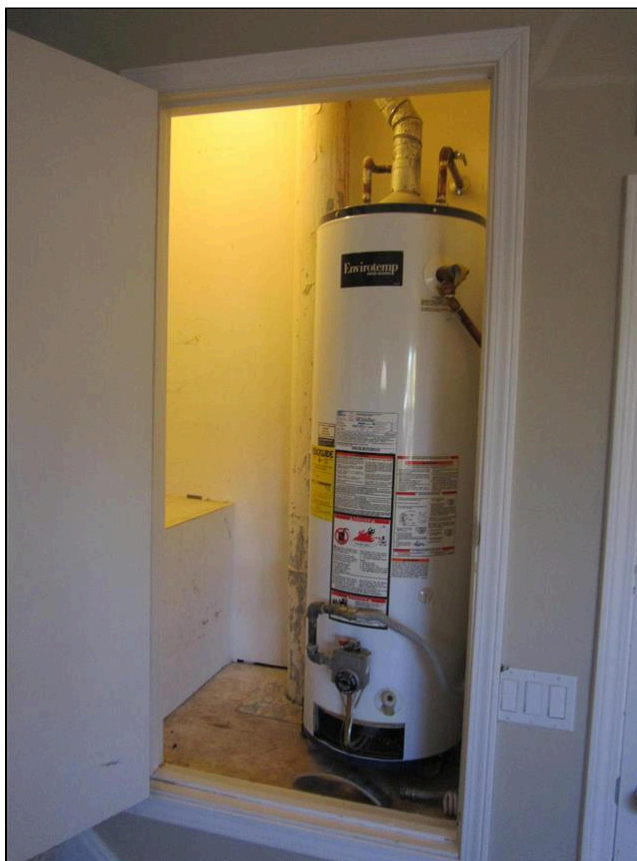
6.2 Item 5(Picture)

**6.2** (4) There is no combustion air to the water heater. This is required for proper operation of this item and is a code concern. I recommend repair by a licensed HVAC contractor.

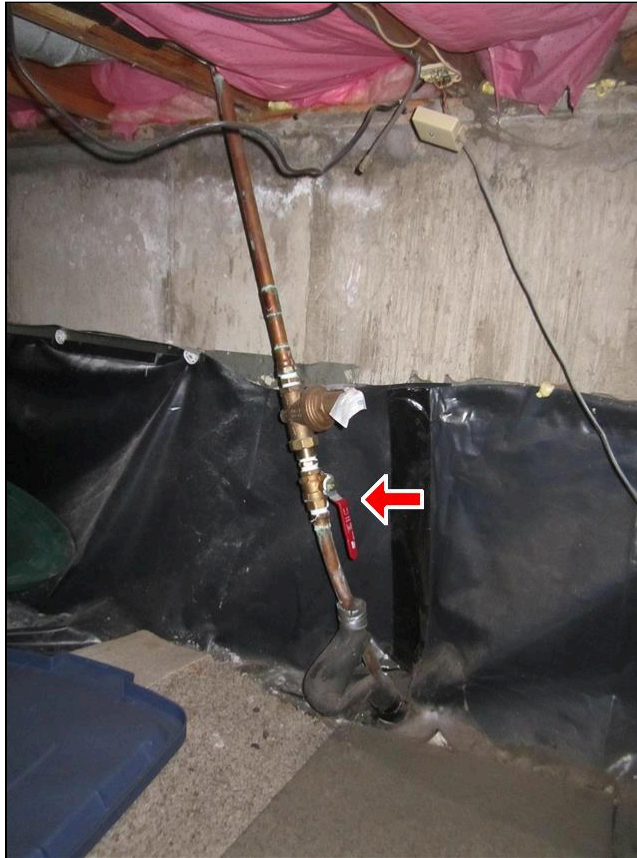
6.3 Item 1(Picture)

6.3 The main shut off is the lever located in the crawlspace. This is for your information.

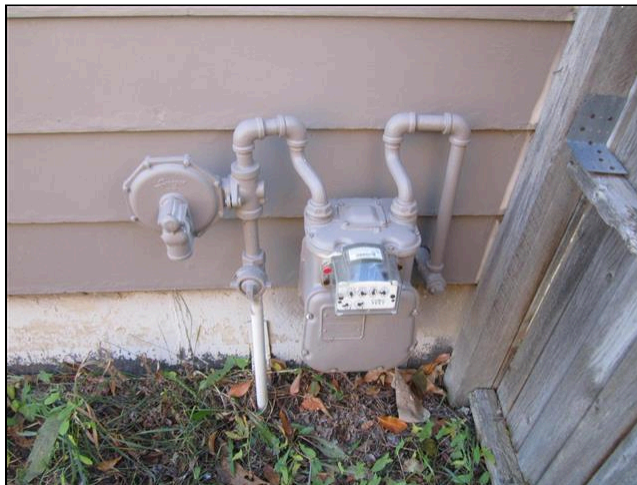
6.5 Item 1(Picture)

6.5 The main fuel shut off is at gas meter outside.

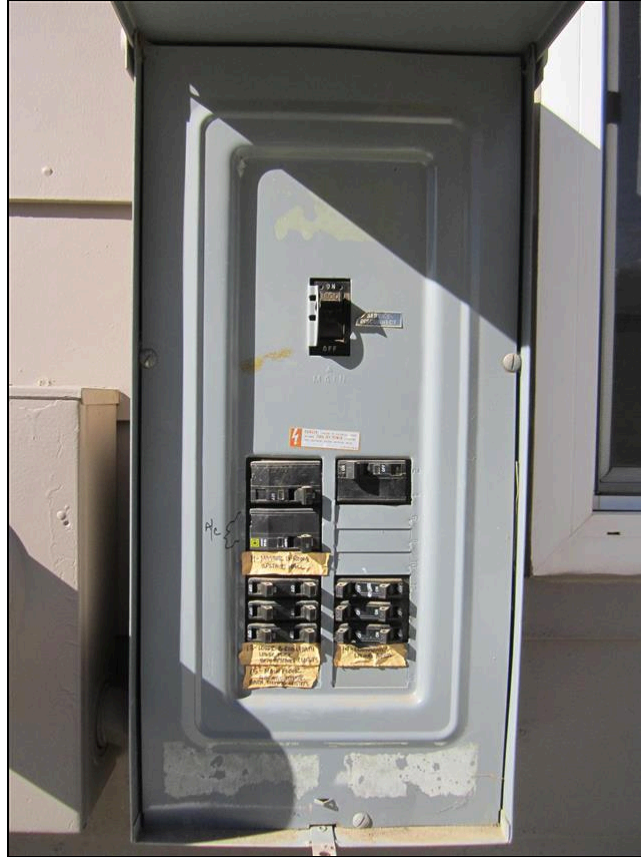
7.1 Item 1(Picture)

7.1 The main panel has multiple circuit breakers that need labels identifying their location(s). I recommend further evaluation and repair as needed by a qualified person/contractor.

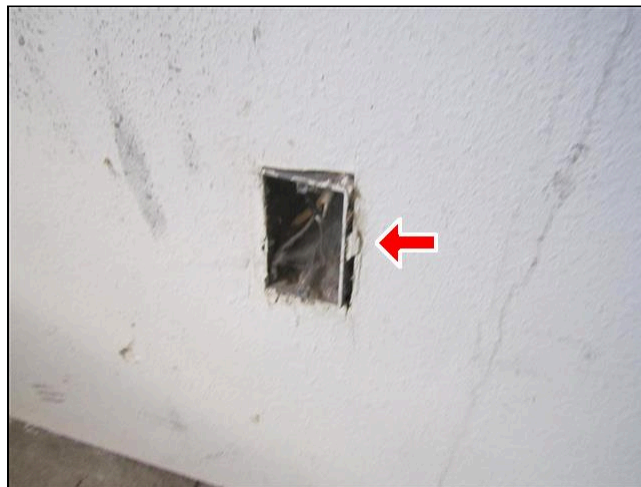
7.3 Item 1(Picture)

7.3 (1) One junction box needs a cover-plate in the garage. I recommend repair as needed by an electrical contractor/ person.

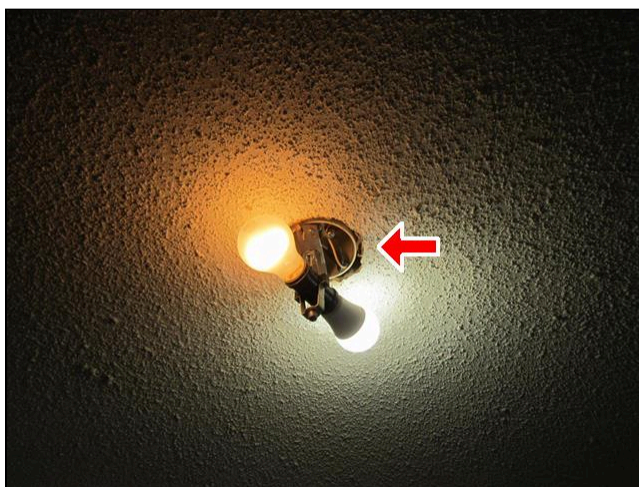
7.3 Item 2(Picture)

🏠 7.3 (2) The light fixture has exposed conductors in the basement bedroom. I recommend repair as needed.

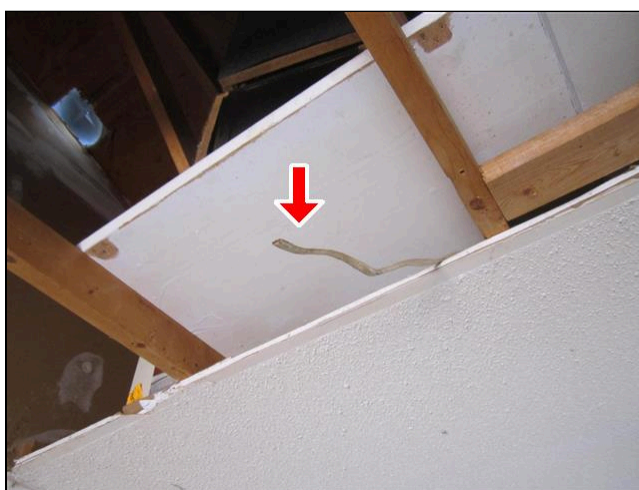
7.3 Item 3(Picture)

🏠 7.3 (3) One loose wire end needs placing inside a box with a cover-plate or need to be removed in the garage. I recommend further evaluation and repair as needed by a licensed electrical contractor.

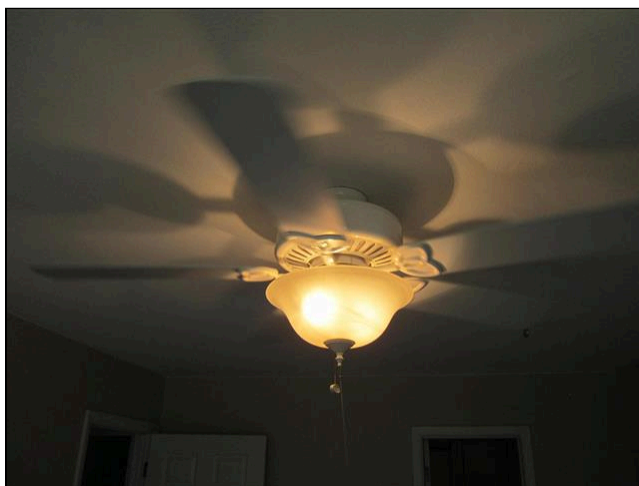
7.3 Item 4(Picture)

🏠 7.3 (4) The ceiling fan does work, but "wobbles" in the master bedroom. This is for your information. I recommend continued monitoring and repair/replace as needed.

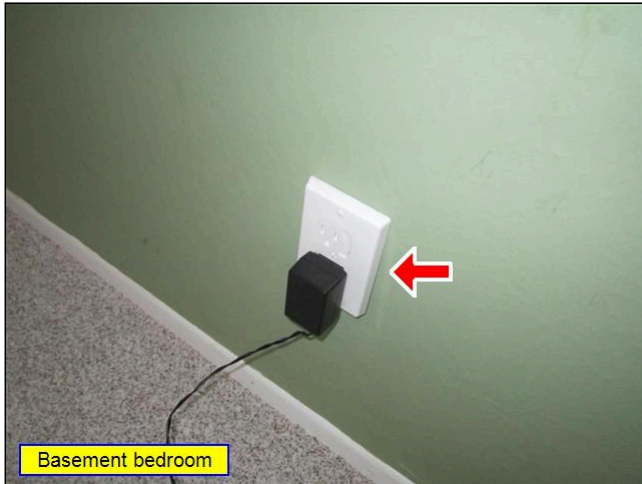
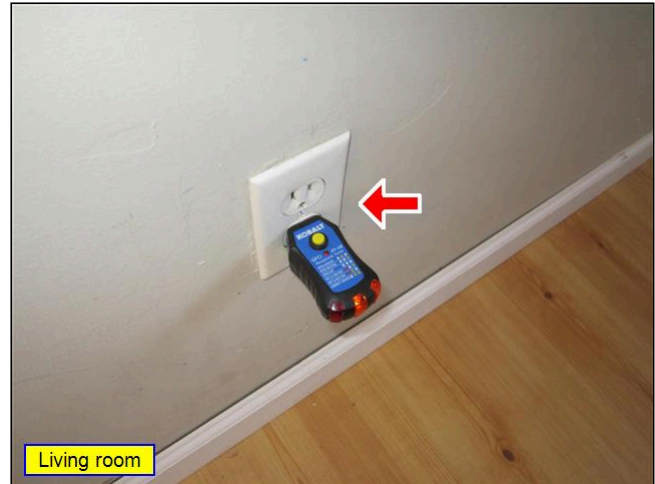
7.4 Item 1(Picture)

🏠 7.4 (1) Several "three-prong" outlets are loose in wall throughout the home. This is for your information. A qualified person should repair as needed.

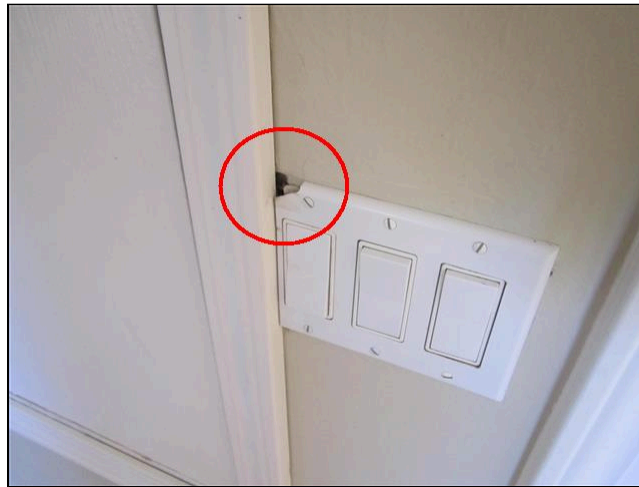
7.4 Item 3(Picture)

🏠 7.4 (2) The cover plate is damaged at the bottom of the stairs. I recommend repair as needed.

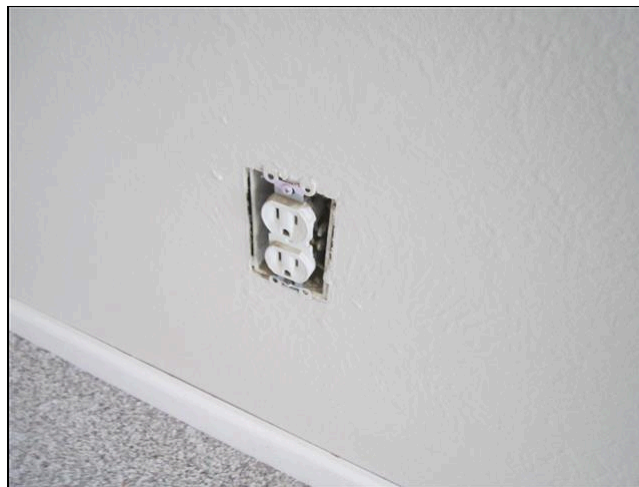
7.4 Item 4(Picture)

🏠 7.4 (3) The cover plate is missing at the electrical outlet in the master bedroom. I recommend repair as needed.

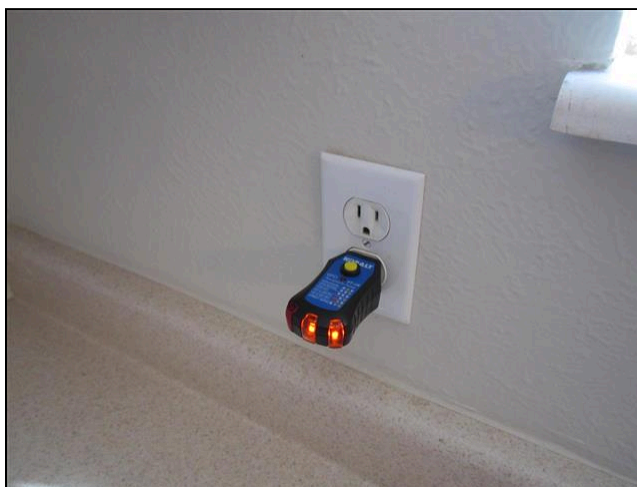
7.5 Item 1(Picture)

🏠 7.5 There are no GFCI outlets in the kitchen. GFCI outlets are needed in areas near water and the exterior. Repairs are

needed. All electrical work should be performed by a licensed electrician.

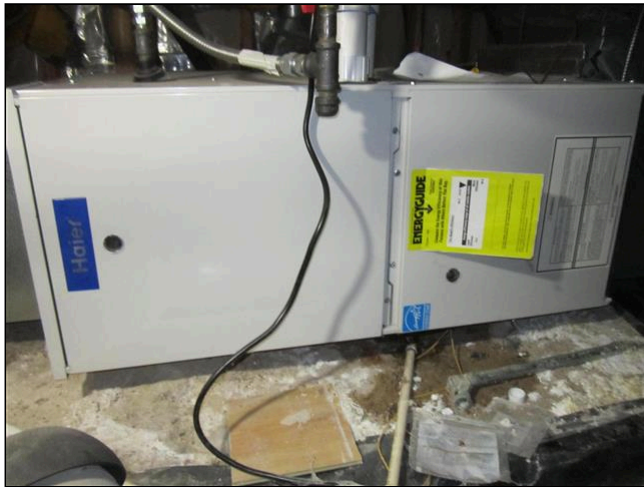
8.0 Item 1(Picture)

8.0 The furnace was mfg in 2007 - typical life is 20 yrs. The unit is dirty/rusty/worn and has been leaking at the condensate drain line connection. Repairs are needed. I recommend cleaning/servicing and repairing the furnace as needed by a licensed HVAC contractor.
