# Inspection Report

**Property Address:**  
17899 E. Princeton Pl.  
Aurora CO 80013

**Colorado Pro Inspect LLC**

<b>Date:</b> 10/29/2022	<b>Time:</b> 11:00 AM	<b>Report ID:</b> 22066
<b>Property:</b> 17899 E. Princeton Pl. Aurora CO 80013	<b>Customer:</b> Beverly Felipe	<b>Real Estate Professional:</b> Christy Holguin

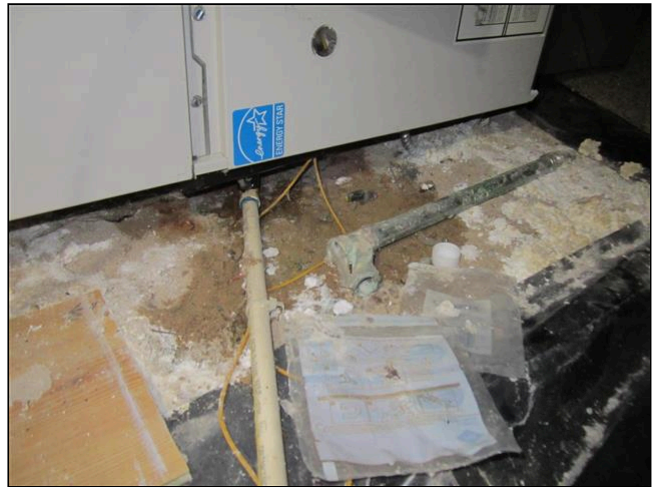
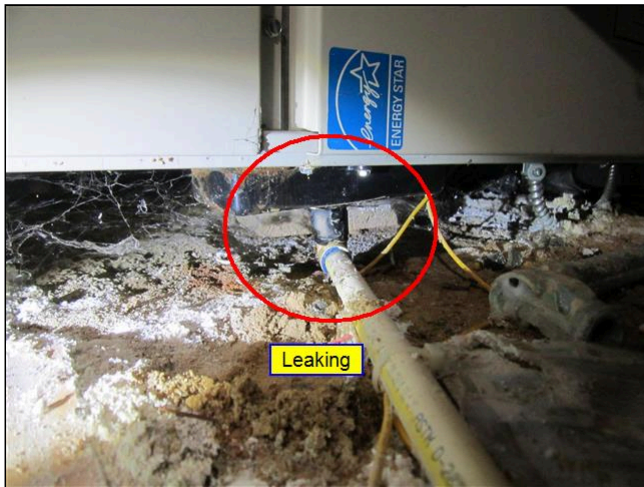
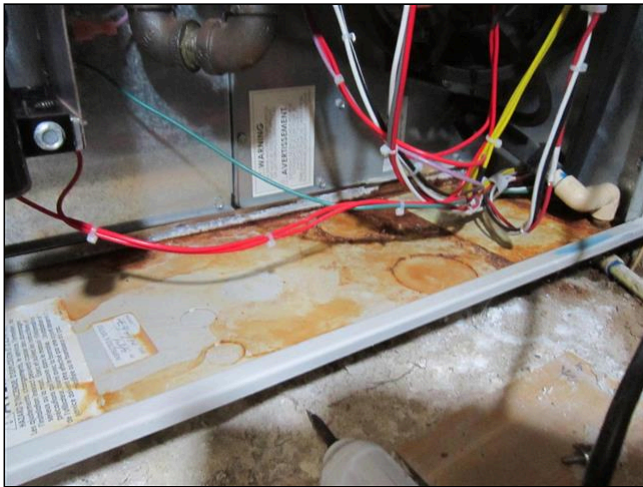
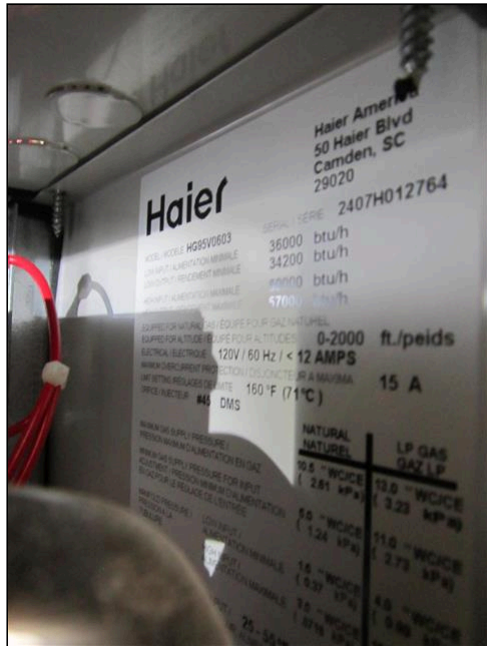
8.0 Item 2(Picture)

8.0 The furnace was mfg in 2007 - typical life is 20 yrs. The unit is dirty/rusty/worn and has been leaking at the condensate drain line connection. Repairs are needed. I recommend cleaning/servicing and repairing the furnace as needed by a licensed HVAC contractor.

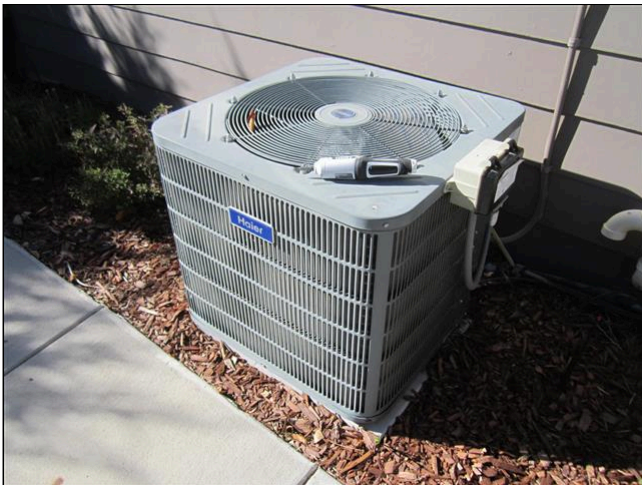
8.8 Item 1(Picture)

8.8 (1) The A/C was mfg in 2009 - typical life is 20-25 yrs. The unit is deteriorated and worn. I recommend clean/service by a licensed HVAC contractor.

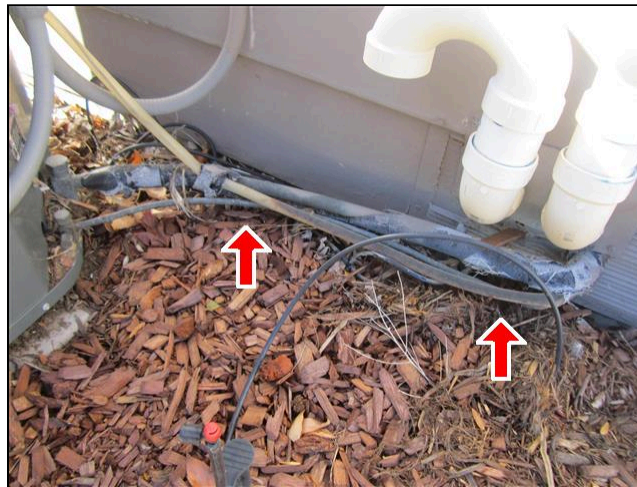
8.8 Item 4(Picture)

**8.8 (3)** The foam sleeve on suction line is deteriorated in area(s) at outside unit. Deteriorated foam on suction line can cause energy loss and condensation. I recommend service or repair as needed.

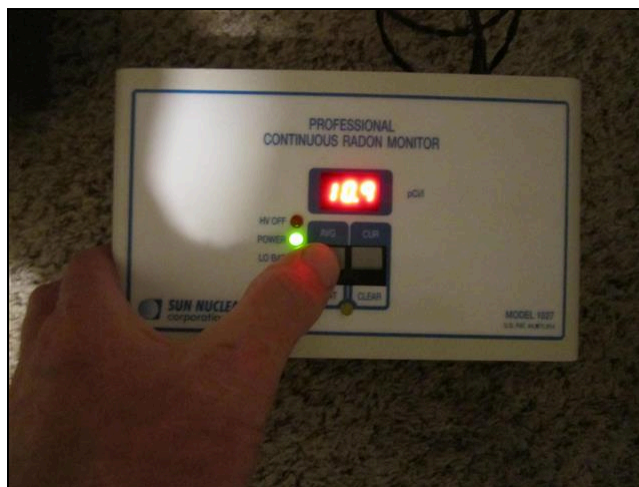
9.3 Item 1(Picture)

**9.3** A radon test was performed at the above property. The test came back over the EPA max recommended limit of 4.0 at 10.9. Based on this test I recommend a radon mitigation system be installed by a qualified contractor. Radon mitigation systems typically cost between \$1500 and \$3000. I recommend repair as needed by a qualified contractor. The report is located under the "attachments" section of this report

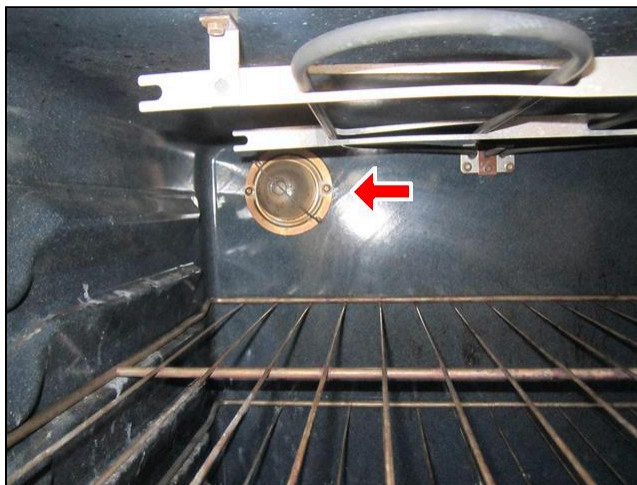
10.1 Item 1(Picture)

**10.1** The light bulb (in oven) did not work when tested. I recommend repair as needed.

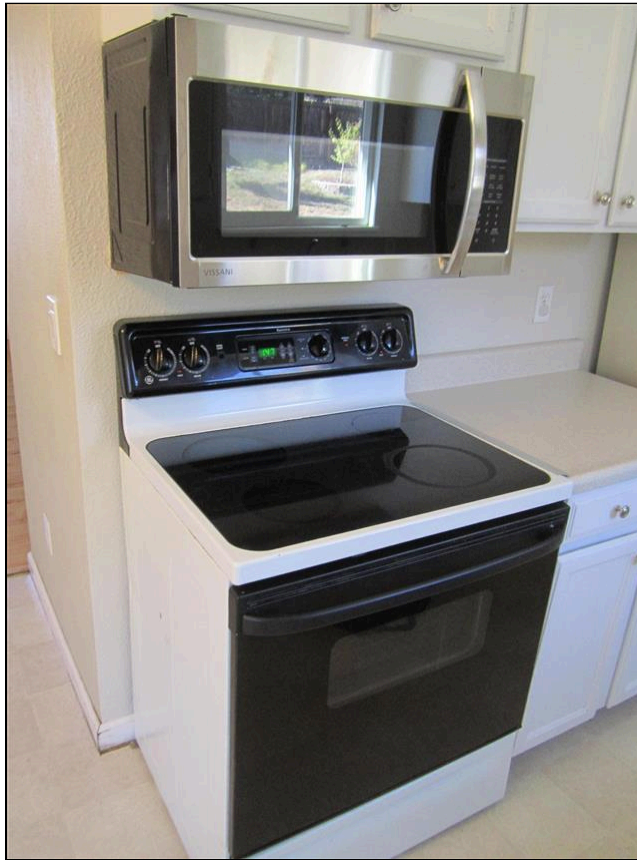
10.5 Item 1(Picture)

🏠 10.5 The microwave appears to be installed too low to burners and the manufacturers minimum distance requirements should be determined. I recommend further evaluation and repair as needed.

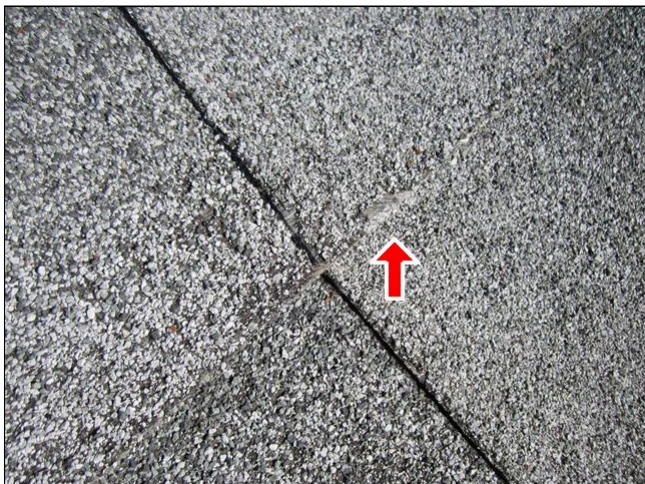
1.0 Item 1(Picture)

The roof shingles are deteriorated/damaged/worn in areas. Repairs are needed. I recommend further evaluation and repair/certify for 5 years or replace as determined by a licensed roofer.

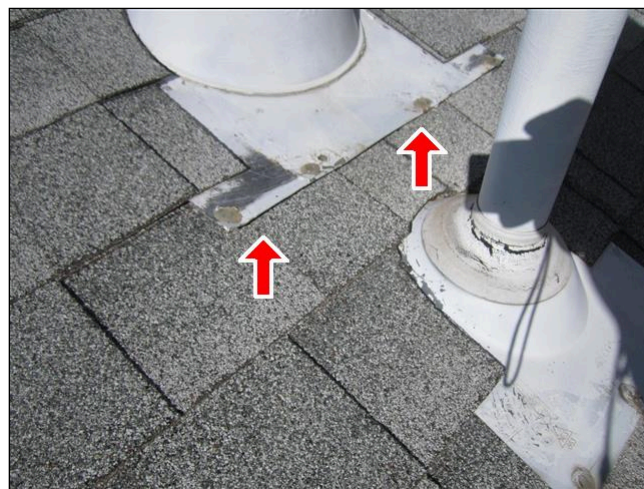
1.1 Item 1(Picture)

The vent pipe flashing on the roof is loose. I recommend further evaluation and repair as needed by a qualified person/contractor.

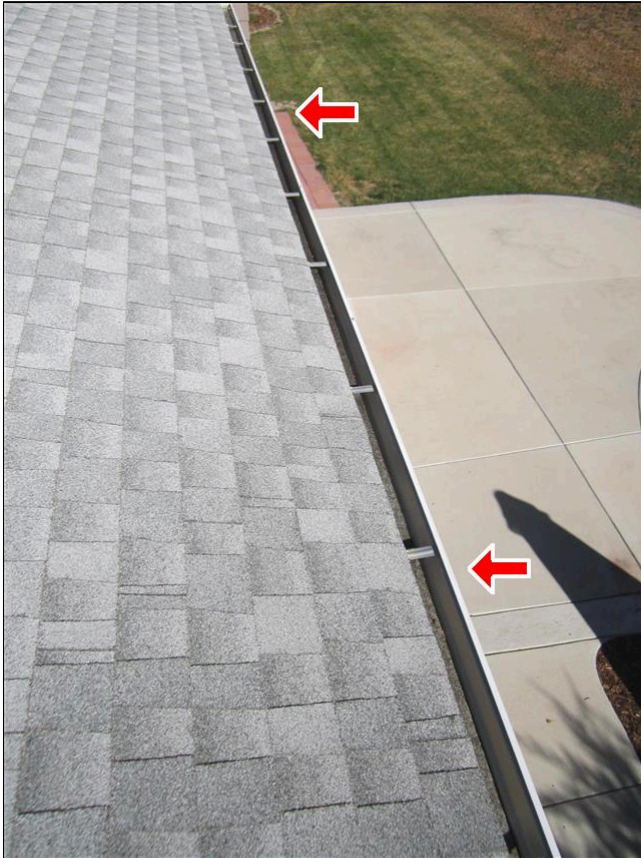
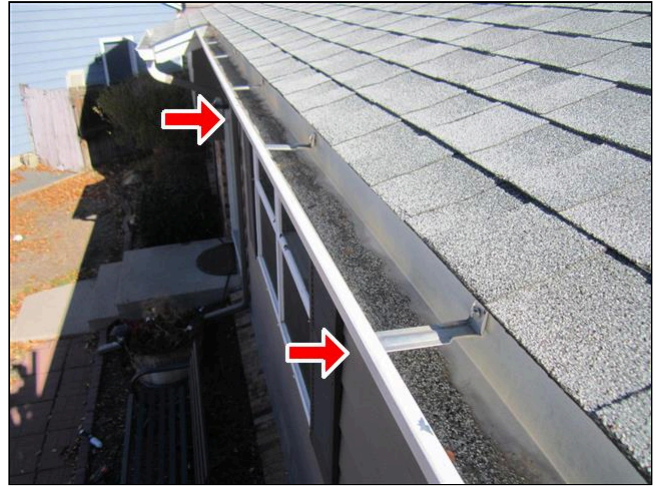
1.3 Item 1(Picture)

The gutters are full of debris in areas and need to be cleaned. The debris in gutters can also conceal rust, deterioration or leaks that are not visible until cleaned, and I am unable to determine if such conditions exist. I recommend further evaluation and repair/clean as needed by a qualified person.

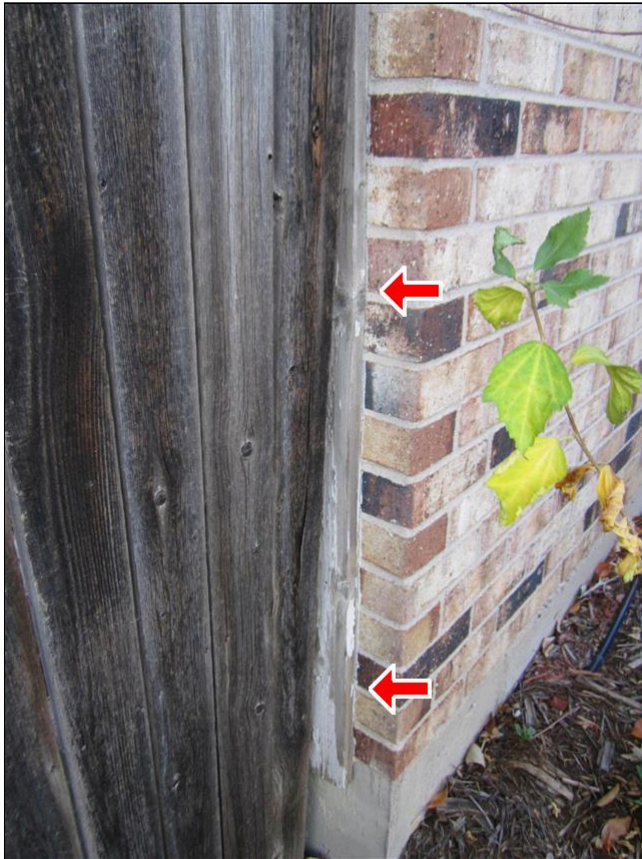
2.0 Item 1(Picture)

(1) The wood trim/siding at the exterior is deteriorated/damaged and worn in areas. This is a maintenance issue. I recommend further evaluation/continued monitoring and repair as needed by a qualified person/contractor.

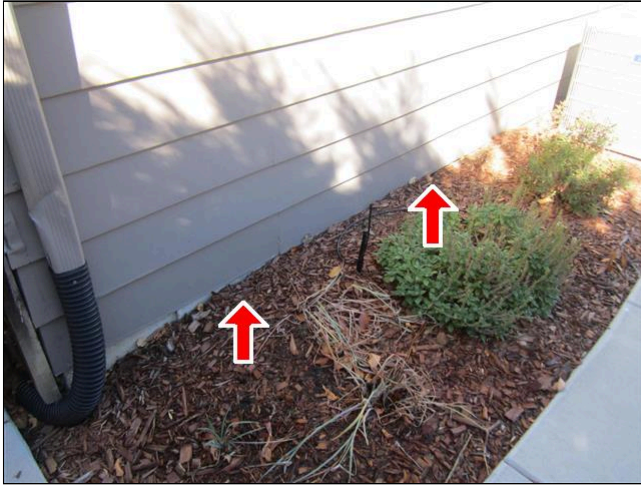
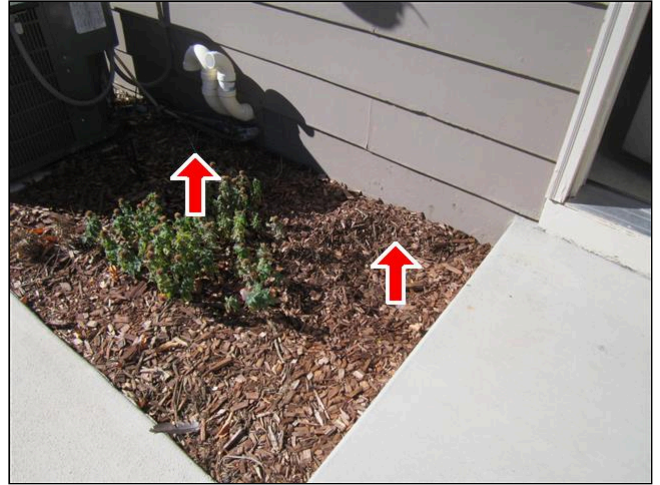
2.0 Item 5(Picture)

(2) The siding at the exterior is in contact with ground in areas. Ground clearance is recommended to prevent possible water infiltration, deterioration and mold growth. A qualified person should repair as needed.

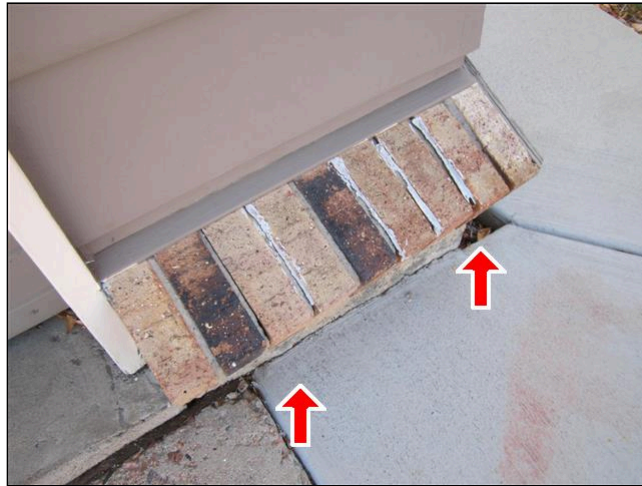
2.0 Item 7(Picture)

(3) There are several bricks loose at the right side of the garage. Repairs are needed. I recommend further evaluation and repair as needed by a qualified contractor.

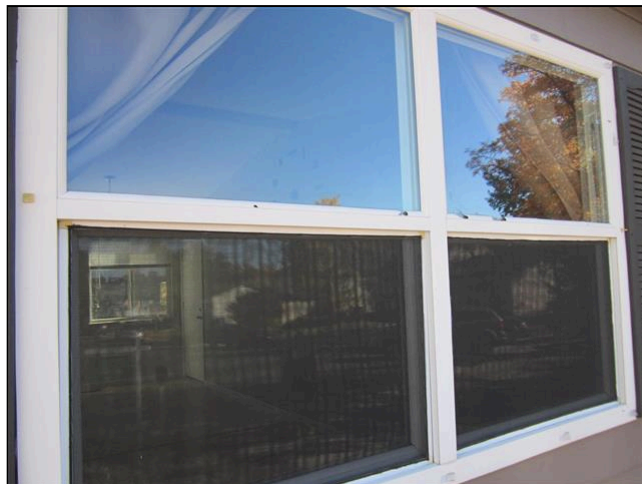
2.2 Item 1(Picture)

(1) The window frame's are damaged at front of home. This is for your information. I recommend continued monitoring and repair/replace as needed.

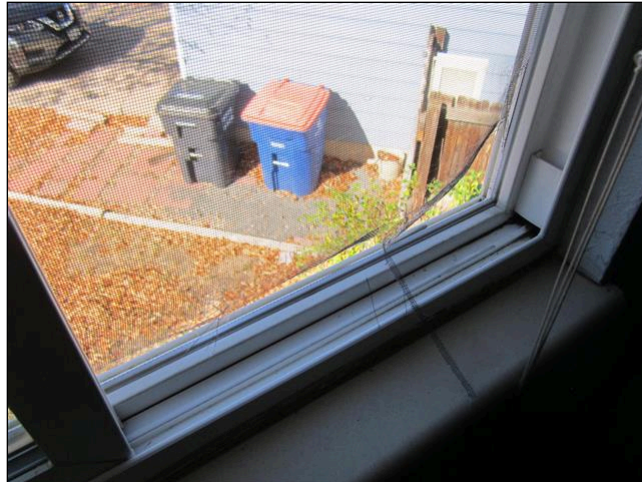
2.2 Item 2(Picture)

(2) The window screens are deteriorated/damaged/worn or missing at several windows. This is for your information. I recommend repair as needed/desired.

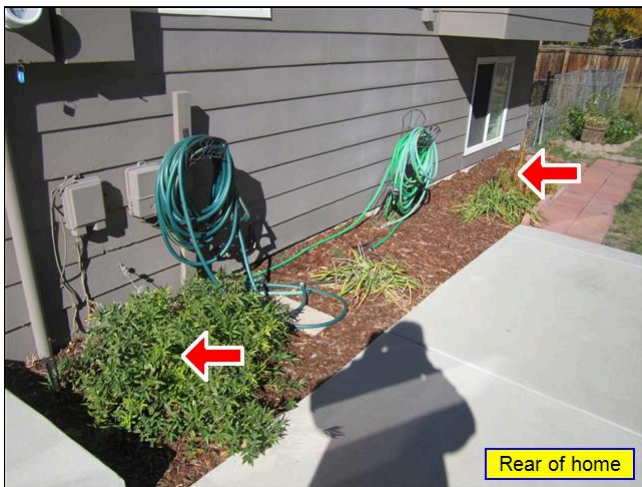
2.4 Item 1(Picture)

(1) There is a negative slope at the front, rear and sides of home and can cause or contribute to water intrusion or deterioration. I recommend correcting landscape to drain water away from home as needed.

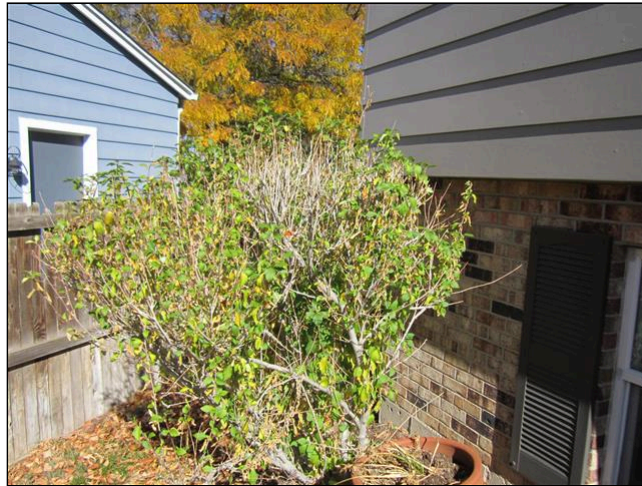
2.4 Item 5(Picture)

(2) The tree limbs and bushes that are in contact with roof or hanging near roof and house should be trimmed or removed. I recommend further evaluation and repair as needed by a qualified person.

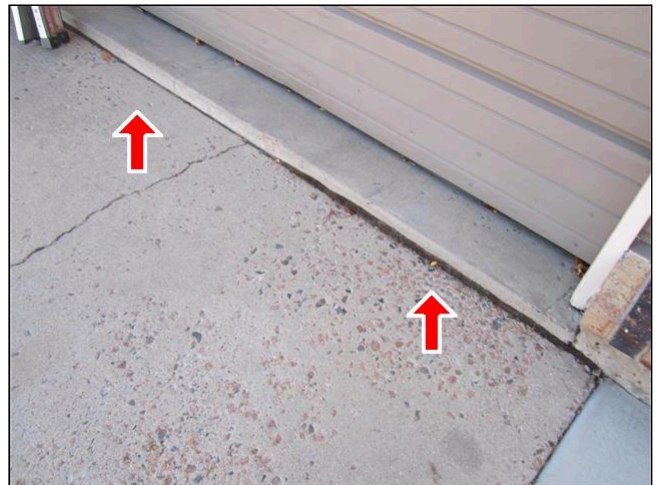
2.4 Item 6(Picture)

(3) The concrete drive at the front of home has settled, has settlement cracks and is damaged/cracked. Repairs are needed. I recommend further evaluation and repair as needed by a qualified contractor.

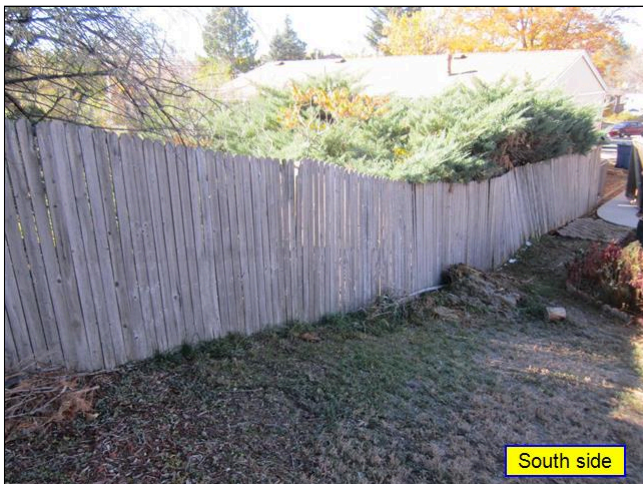
2.6 Item 1(Picture)

The fence is damaged, worn and loose in areas. Repairs are needed. I recommend further evaluation and repair as needed by a qualified person.

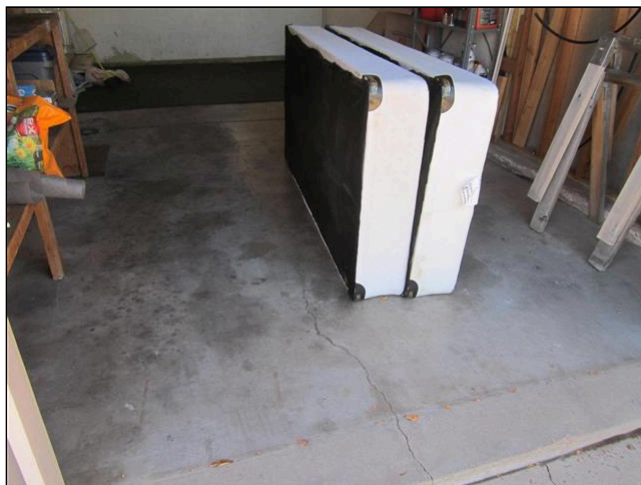
3.2 Item 1(Picture)

The concrete floor of garage has settled/heaved and is cracked in areas. This is for your information. I recommend continued monitoring and repair as needed.

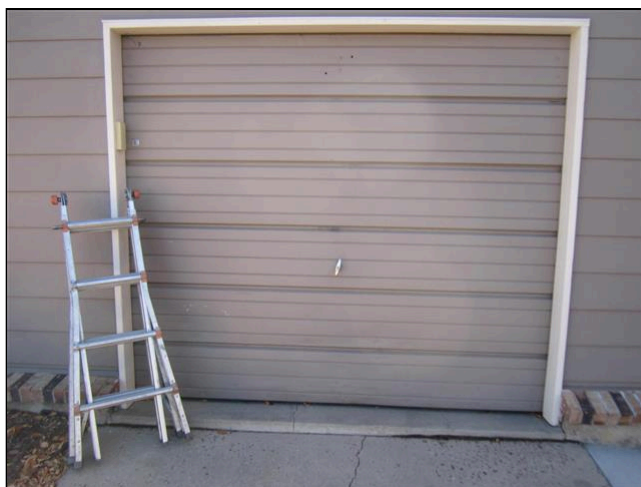
3.3 Item 1(Picture)

The garage door at the front of home is deteriorated/damaged and worn in areas. This is for your information. I recommend continued monitoring and repair as needed.

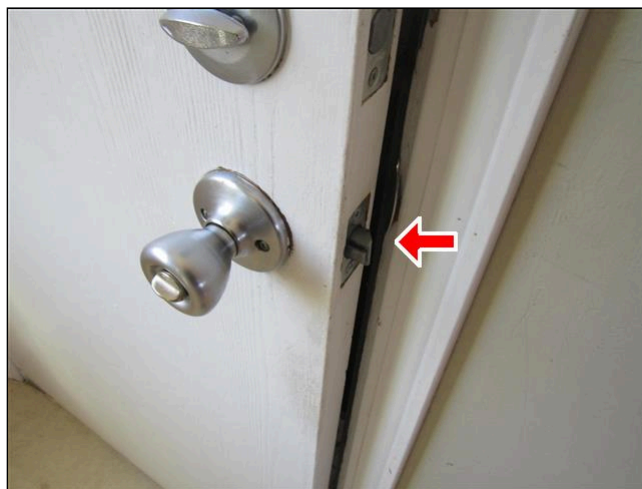
3.4 Item 2(Picture)

(2) The garage entry door lock does not latch properly when closed. I recommend further evaluation and repair as needed by a qualified person.

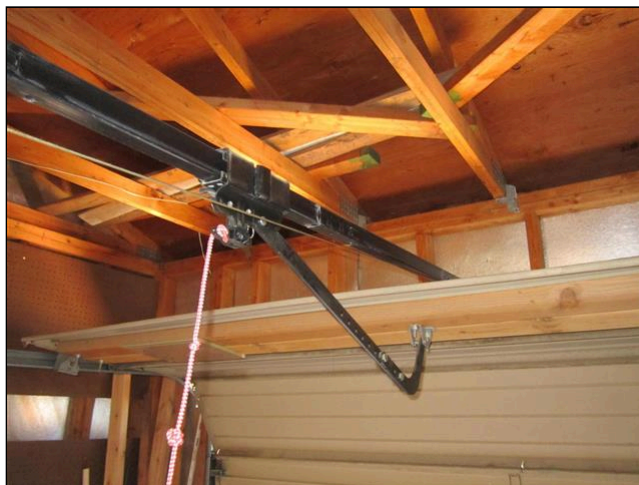
3.5 Item 1(Picture)

The automatic opener for garage door is noisy during operation (chain rubs on the door) and it appears the door is only being lifted by the automatic opener (garage door springs appear disconnected). This is for your information. I recommend continued monitoring and repair as needed.

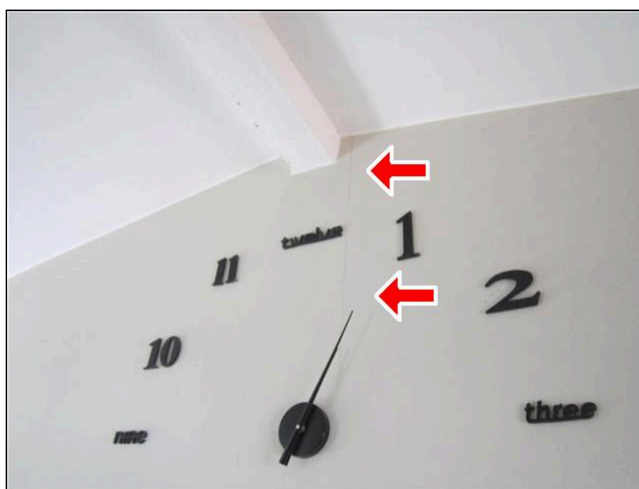
4.1 Item 1(Picture)

The drywall on the wall is cracked at the living room. This is for your information. I recommend continued monitoring and repair as needed.

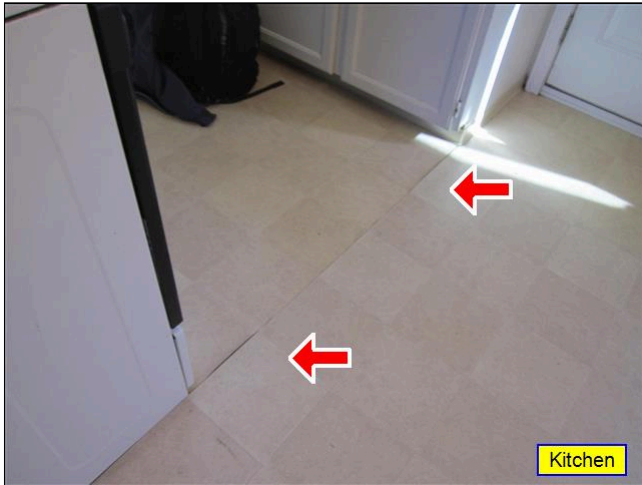
4.2 Item 1(Picture)

(1) There are multiple locations throughout the home where the floor covering is deteriorated and worn. I recommend repair/replace as needed/desired.

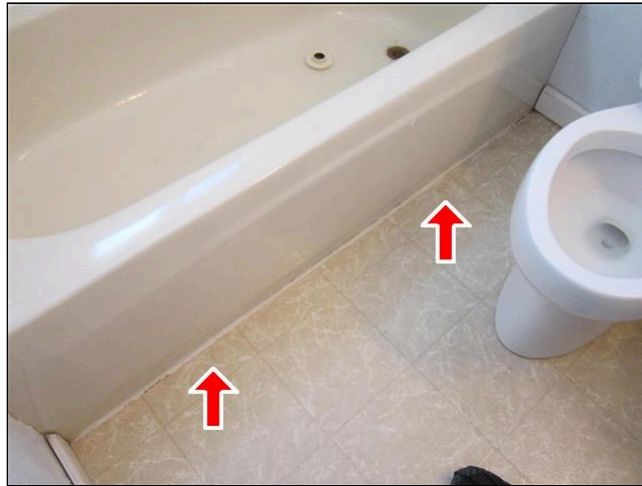
4.2 Item 3(Picture)

(2) The vinyl floor is curling at the upstairs hall bath and has deteriorated/worn caulking along the tub/shower. I recommend repair as needed by a qualified person.

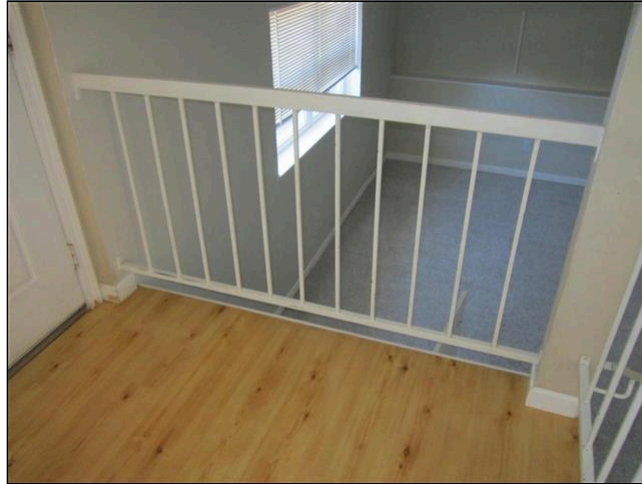
4.3 Item 2(Picture)

(2) The pickets on the guard/hand rail at the upstairs are spaced to far apart for safety. Spacing more than 4 inches apart could allow an adult, child or pet to fall through. I recommend further evaluation and repair as needed/desired by a qualified person/contractor.

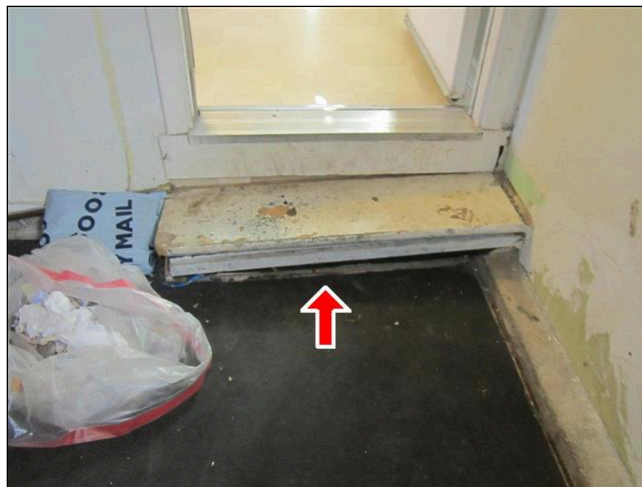
4.3 Item 3(Picture)

(3) The garage door step is uneven. This is for your information. I recommend repair as needed.

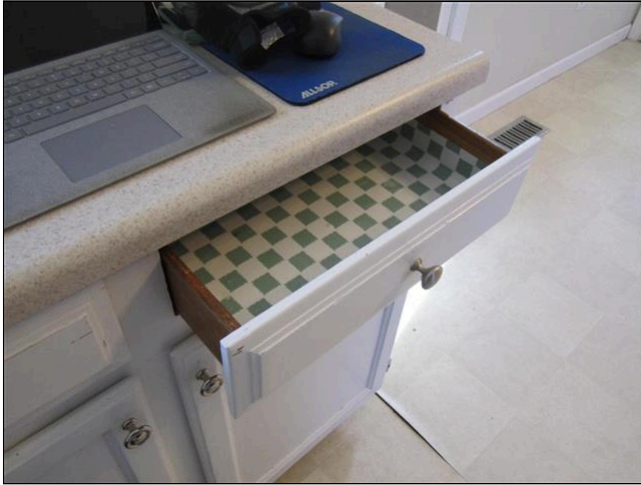
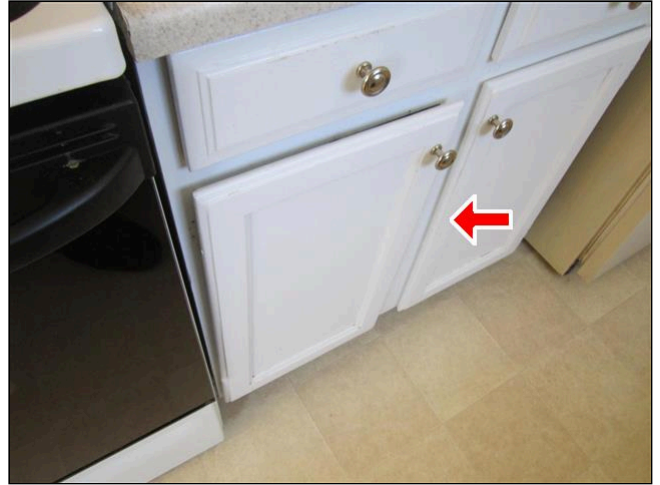
4.4 Item 1(Picture)

There are several cabinet doors/drawers that are damaged/deteriorated and do not close and open properly at the kitchen. I recommend repair as needed

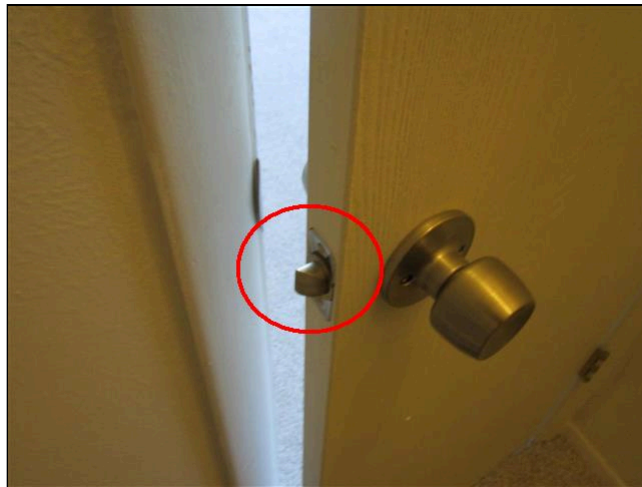
4.5 Item 1(Picture)

The upstairs bedroom closet door does not latch properly when closed (hardware is installed backwards). I recommend repair as needed.

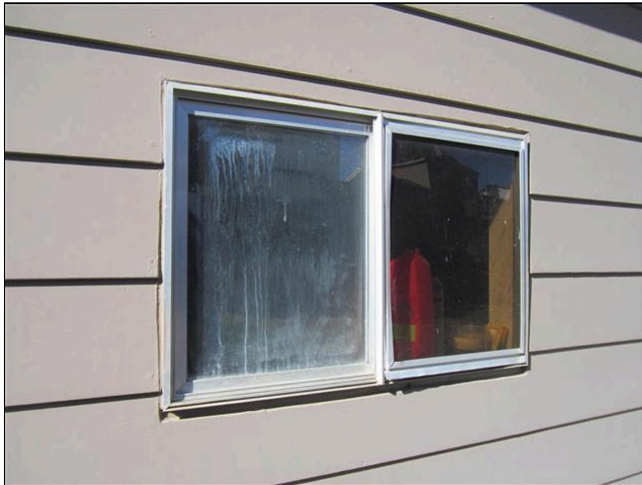
4.6 Item 1(Picture)

(1) One window is damaged/deteriorated and cloudy (lost seal) at the garage. Repairs are needed. A qualified person/contractor should evaluate and repair as needed.

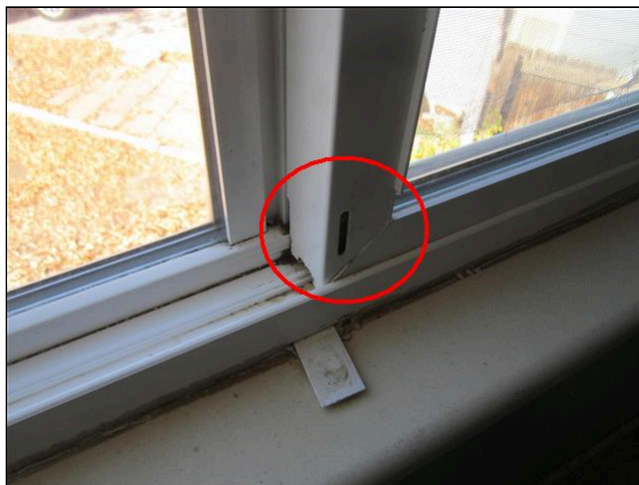
4.6 Item 5(Picture)

(3) The lock hardware is missing at the window in the master bedroom. I recommend repair as needed.

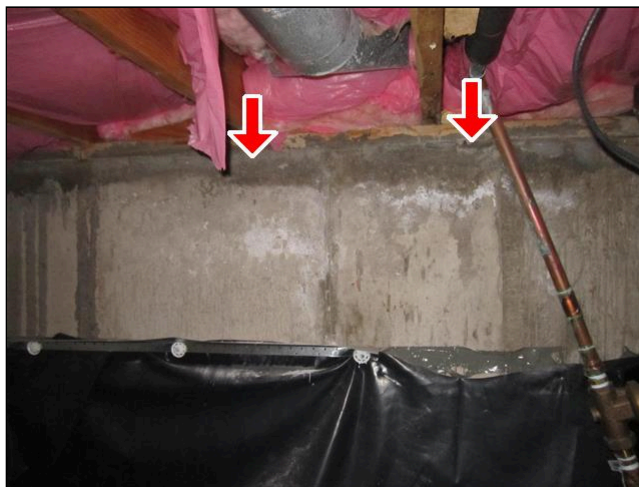
5.0 Item 1(Picture)

(2) White efflorescence (powder substance) on concrete wall indicates moisture is in contact with the masonry. This does not necessarily indicate that intrusion will occur. I recommend checking the gutters and the downspout drain lines for proper operation. Also, a water proofing paint could be applied to the interior side of the concrete if necessary. Efflorescence is found on many homes without water intrusion occurring inside the home. But, it should alert you to the possibility that future steps may be needed. I recommend continued monitoring and repair as needed.

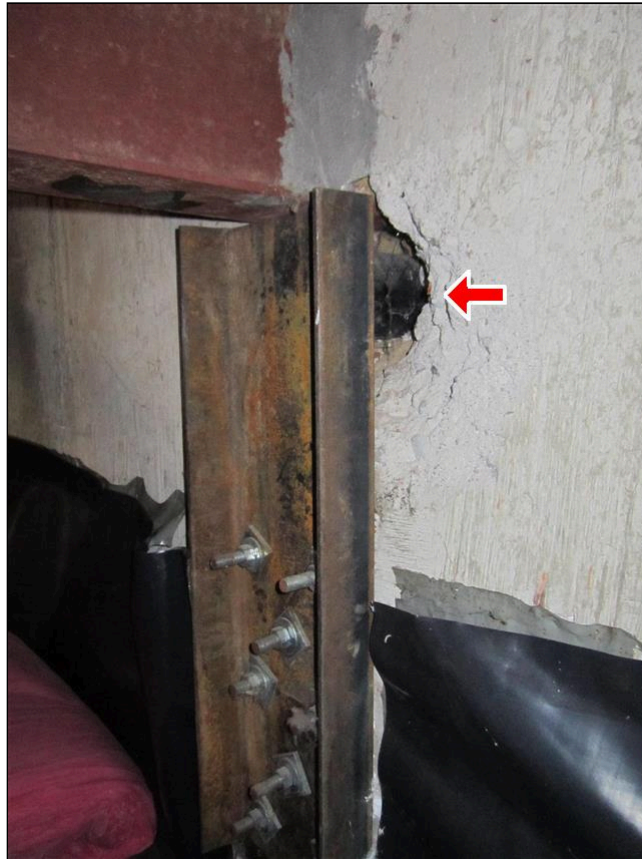
5.0 Item 2(Picture)

(3) The steel beam has been reinforced where it connects to the concrete foundation in the crawlspace. This is for your information. I recommend continued monitoring and repair if needed by a qualified contractor/engineer.

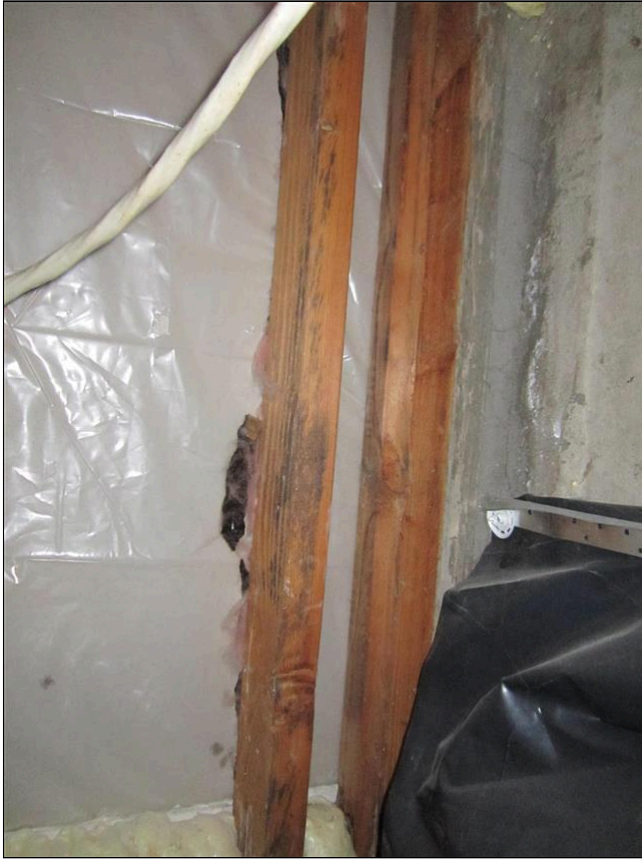
5.1 Item 1(Picture)

(2) The wall framing shows signs of minor fungi/mold growth in the crawlspace behind the basement shower at several locations. This is for your information. I recommend continued monitoring and repair/removal as needed.

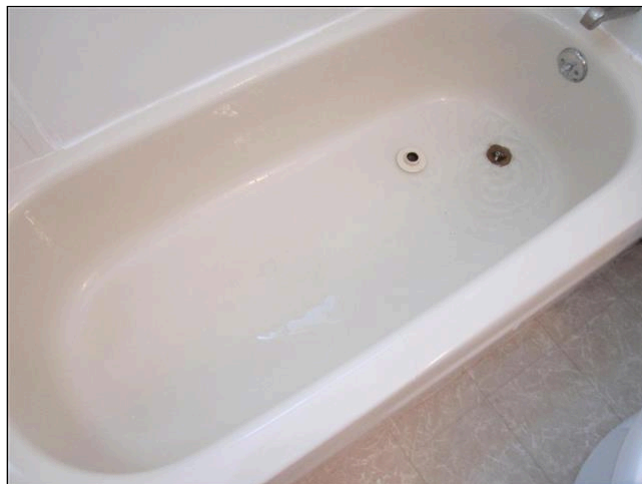
6.0 Item 1(Picture)

(3) The plumbing waste line drains slowly at the upstairs hall bath tub. A cause of a slow drain can range from a simple cleaning at stop valve or at the trap under tub. Sometimes the drain can be partially clogged down line. I am unable to determine the cause of the slow drain. A qualified person should evaluate and repair as needed.

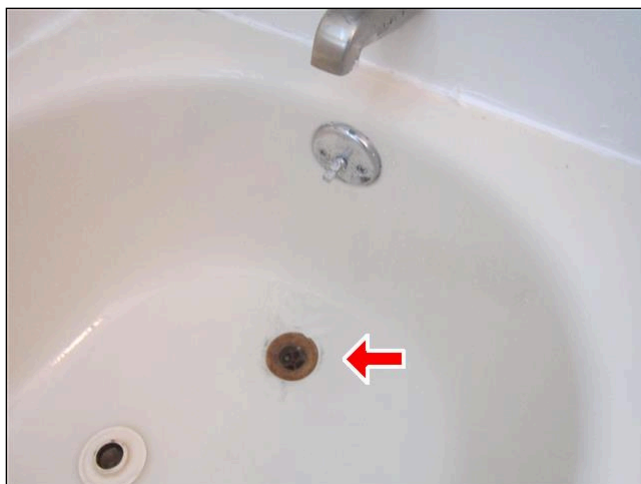
6.0 Item 2(Picture)

- 🏠 (4) The drain stopper at the upstairs hall bath tub is non functional. I recommend repair as needed by a qualified person.

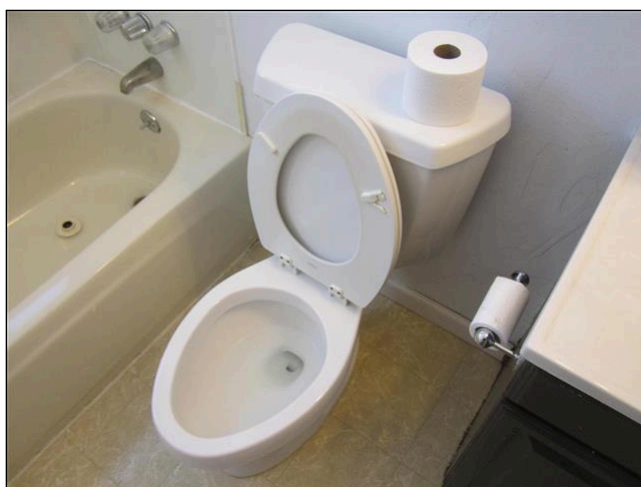
6.0 Item 3(Picture)

- 🏠 (5) The toilet is loose at floor at the upstairs hall bath (appears minor). I recommend further evaluation and repair as needed by a qualified person/contractor.

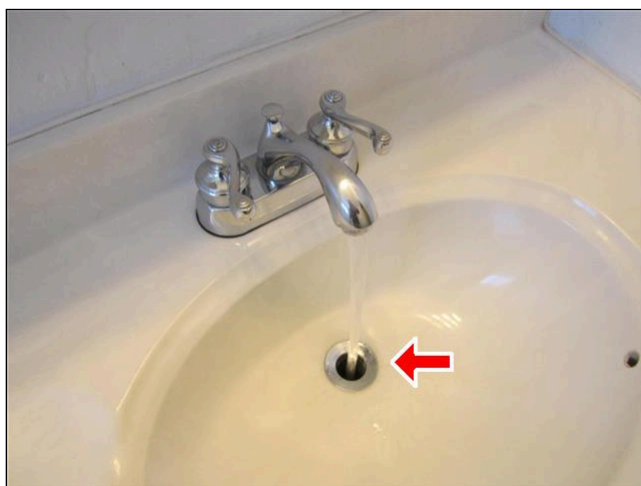
6.0 Item 4(Picture)

- 🏠 (6) The drain stopper at the upstairs hall bath sink is missing and non functional. I recommend repair as needed by a qualified person.

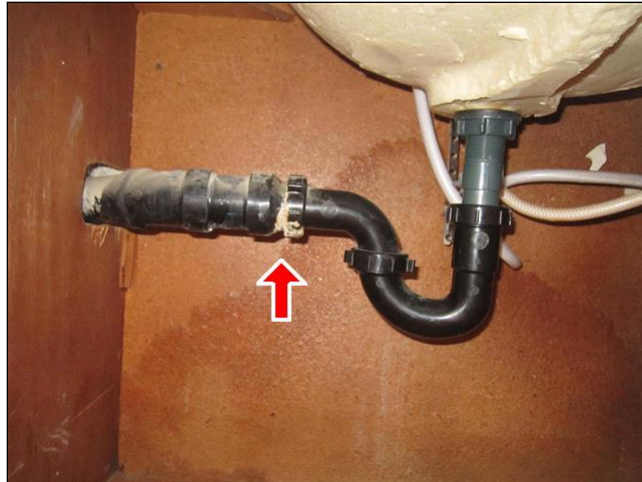
6.0 Item 5(Picture)

(7) The plumbing waste line is corroded at the basement hall bath. This is for your information. I recommend continued monitoring and repair/replace as needed.

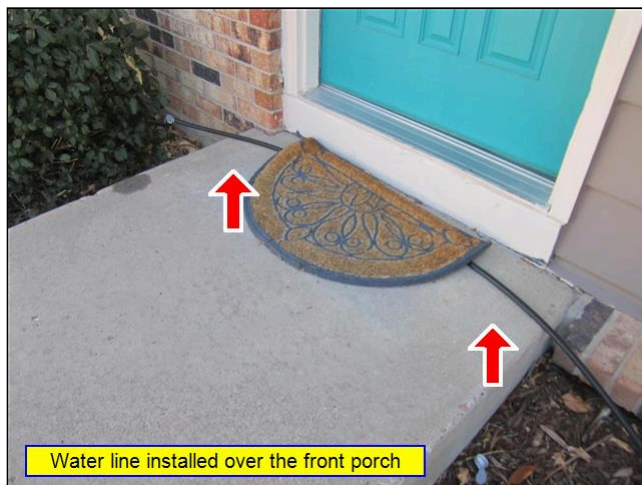
6.1 Item 1(Picture)

(2) The home sprinkler/drip system is installed improperly. the system requires hooking the water supply lines to the exterior faucet connections to operate and all of the water supply lines are installed above grade and susceptible to freezing. Repairs are needed. I recommend further evaluation and repair as needed by a qualified contractor.

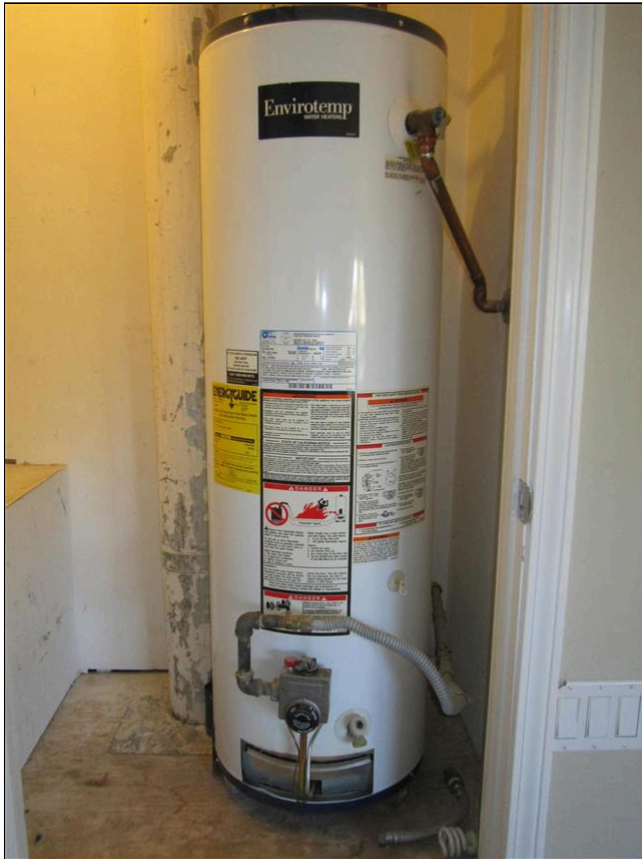
6.2 Item 1(Picture)

(2) The water heater is old (mfg 2003 - typical life is 10-12 yrs), deteriorated/worn and past the end of its life expectancy. No leaks at present, however it is my opinion a replacement unit is needed. I recommend further evaluation and repair/replace as recommended by a licensed plumber.

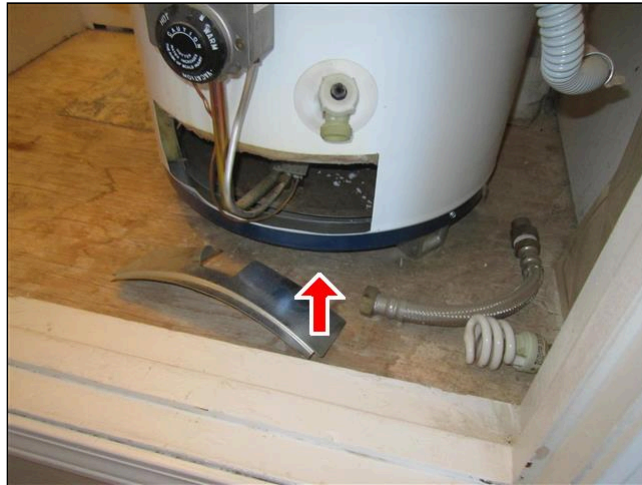
6.2 Item 4(Picture)

(3) The water heater was not installed in a water drain/catch pan at the time of installation. This may help catch water if the unit starts to leak/fail. I recommend repair as needed by a qualified person/contractor.

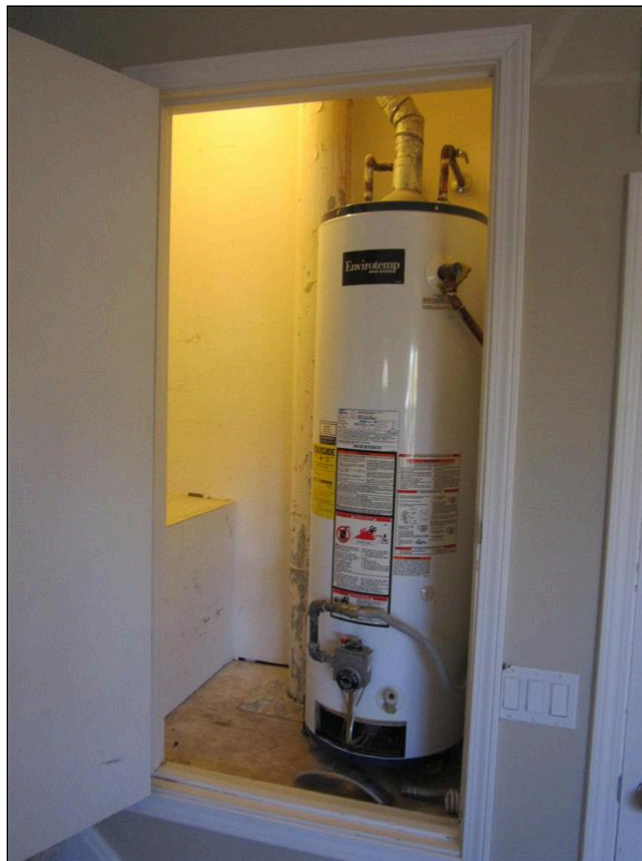
6.2 Item 5(Picture)

(4) There is no combustion air to the water heater. This is required for proper operation of this item and is a code concern. I recommend repair by a licensed HVAC contractor.

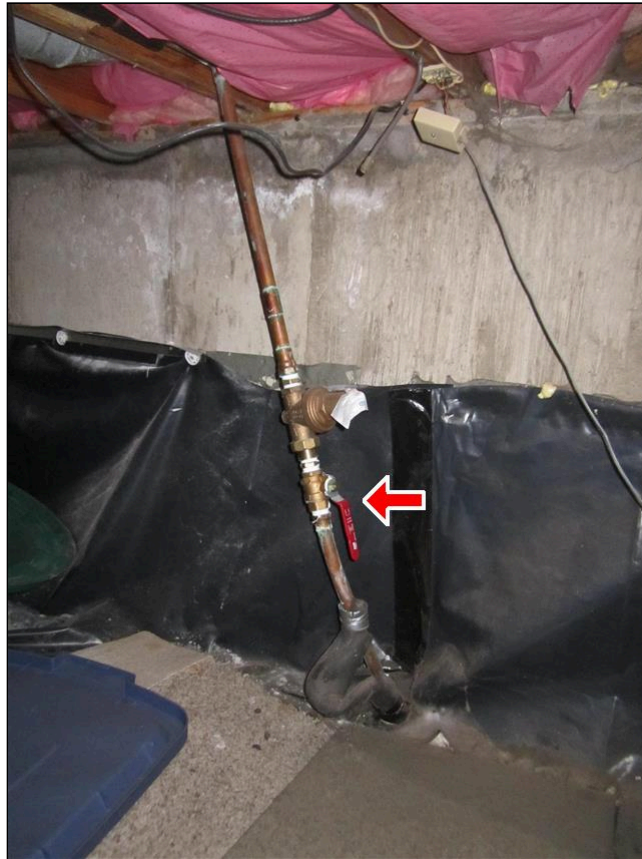
6.3 Item 1(Picture)

The main shut off is the lever located in the crawlspace. This is for your information.

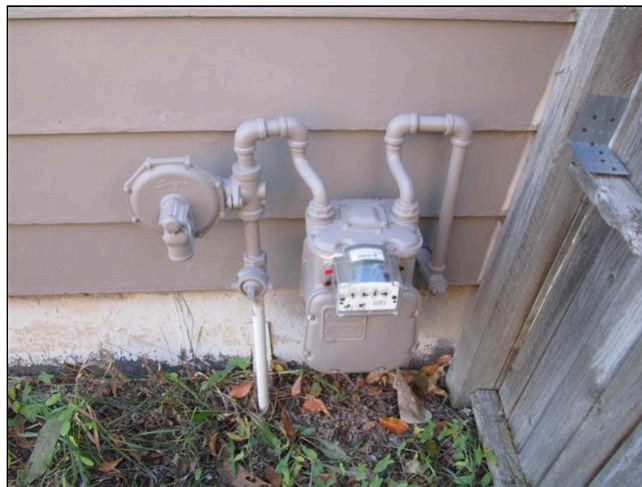
6.5 Item 1(Picture)

The main fuel shut off is at gas meter outside.

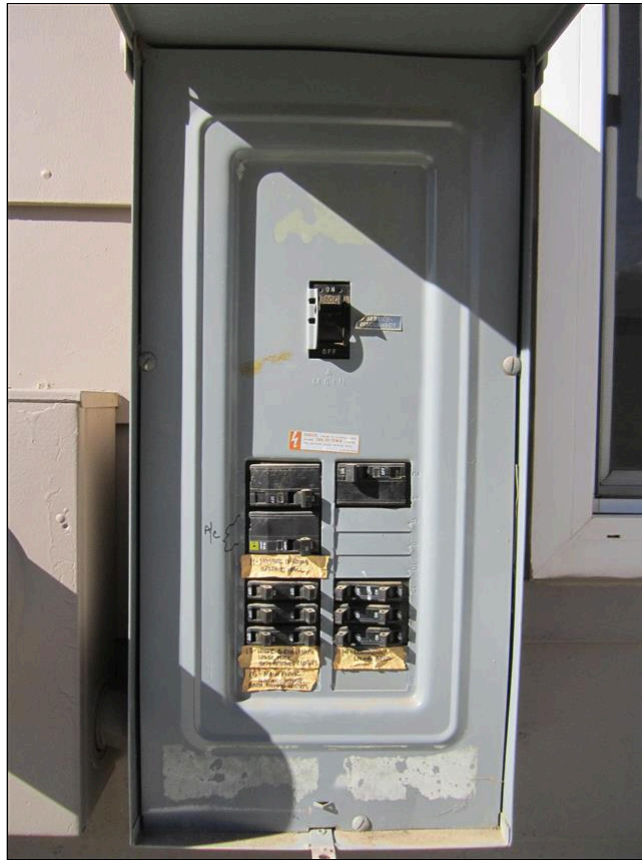
7.1 Item 1(Picture)

evaluation and repair as needed by a qualified person/contractor.

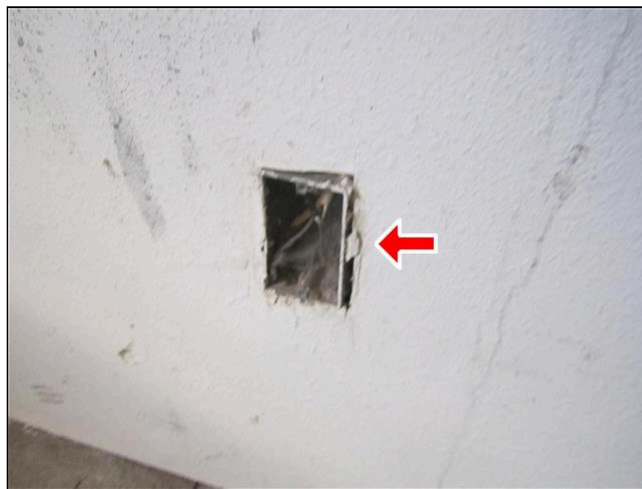
7.3 Item 1(Picture)

(1) One junction box needs a cover-plate in the garage. I recommend repair as needed by a electrical contractor/ person.

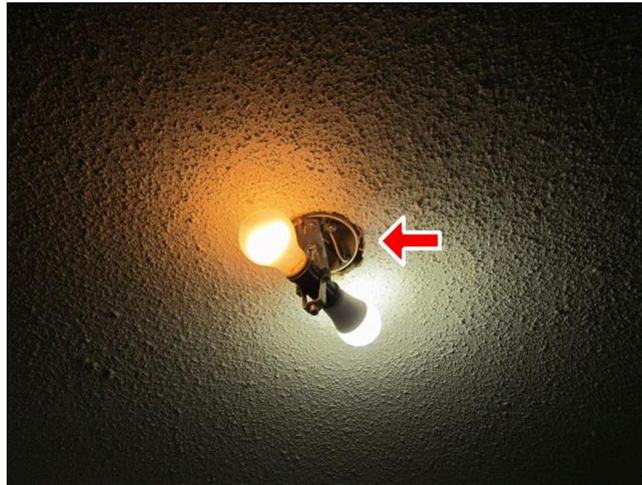
7.3 Item 2(Picture)

(2) The light fixture has exposed conductors in the basement bedroom. I recommend repair as needed.

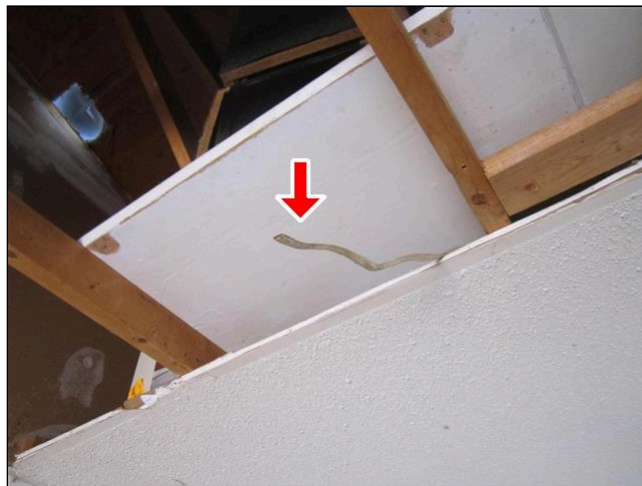
7.3 Item 3(Picture)

(3) One loose wire end needs placing inside a box with a cover-plate or need to be removed in the garage. I recommend further evaluation and repair as needed by a licensed electrical contractor.

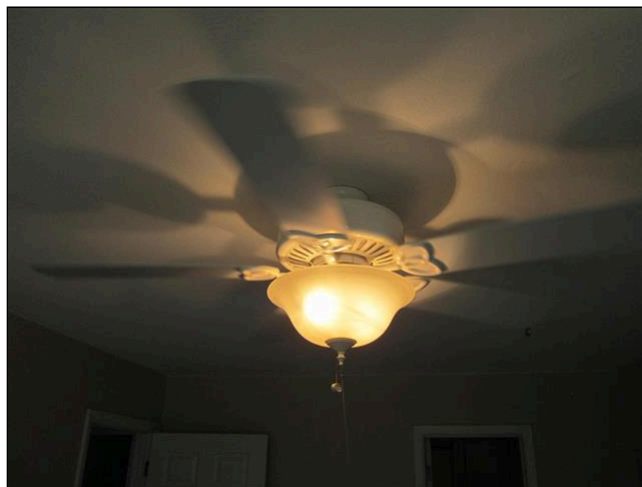
7.3 Item 4(Picture)

(4) The ceiling fan does work, but "wobbles" in the master bedroom. This is for your information. I recommend continued monitoring and repair/replace as needed.

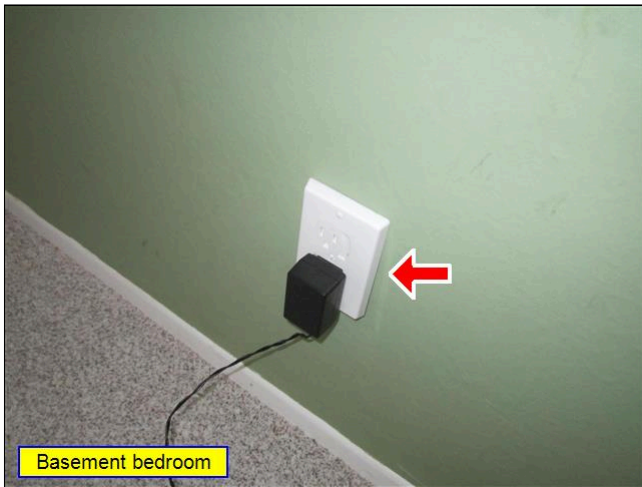
7.4 Item 1(Picture)

(1) Several "three-prong" outlets are loose in wall throughout the home. This is for your information. A qualified person should repair as needed.
