# Inspection Report

**Property Address:**  
17899 E. Princeton Pl.  
Aurora CO 80013

**Colorado Pro Inspect LLC**

<b>Date:</b> 10/29/2022	<b>Time:</b> 11:00 AM	<b>Report ID:</b> 22066
<b>Property:</b> 17899 E. Princeton Pl. Aurora CO 80013	<b>Customer:</b> Beverly Felipe	<b>Real Estate Professional:</b> Christy Holguin

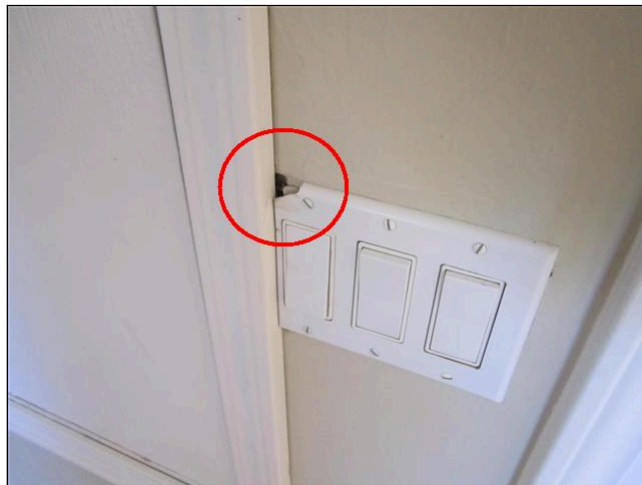
7.4 Item 3(Picture)

(2) The cover plate is damaged at the bottom of the stairs. I recommend repair as needed.

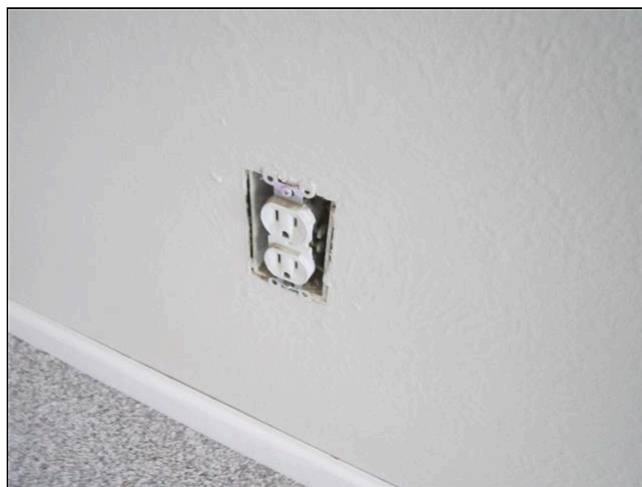
7.4 Item 4(Picture)

(3) The cover plate is missing at the electrical outlet in the master bedroom. I recommend repair as needed.

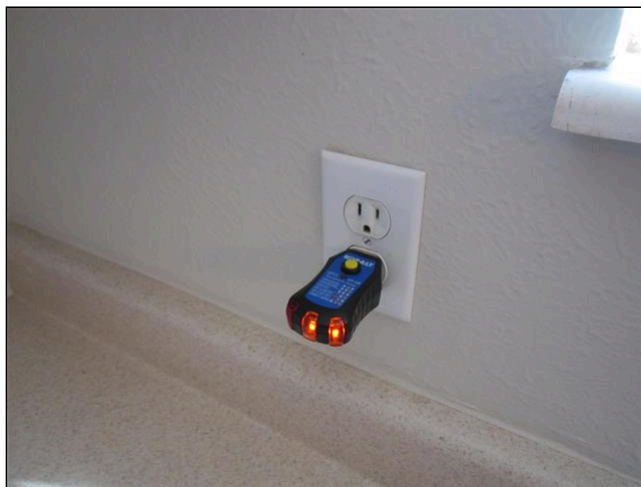
7.5 Item 1(Picture)

There are no GFCI outlets in the kitchen. GFCI outlets are needed in areas near water and the exterior. Repairs are needed. All electrical work should be performed by a licensed electrician.

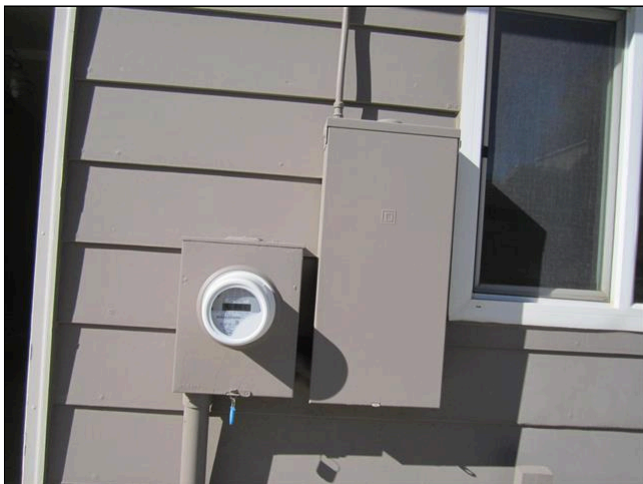
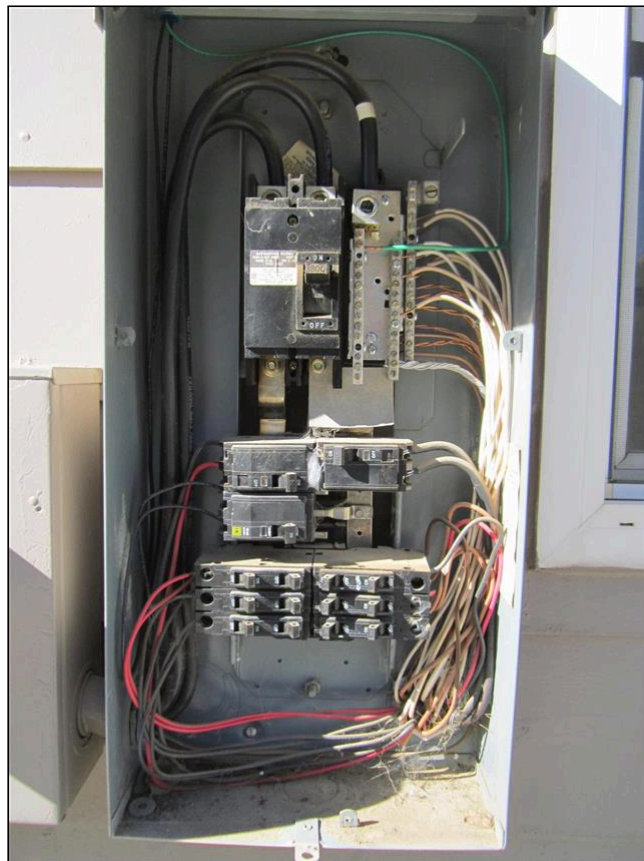
7.6 Item 1(Picture)

The main panel box is located at the outside on the rear of home.

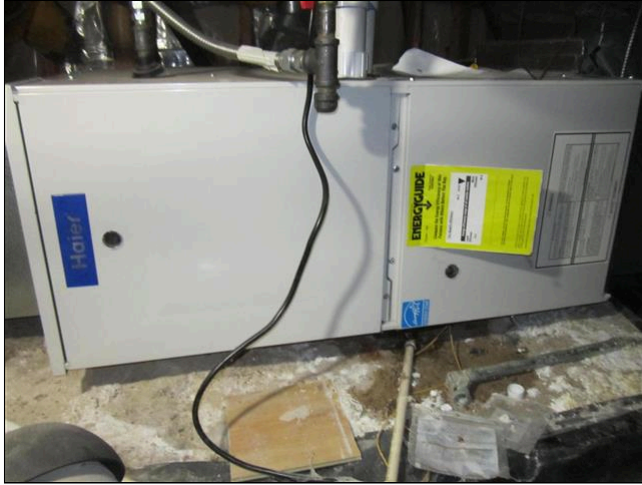
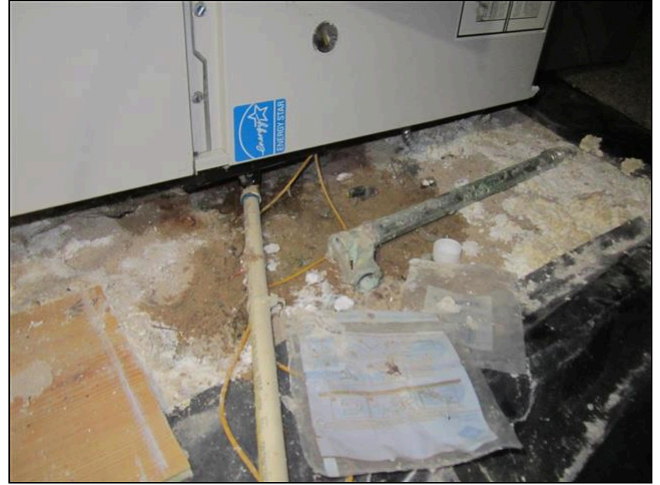
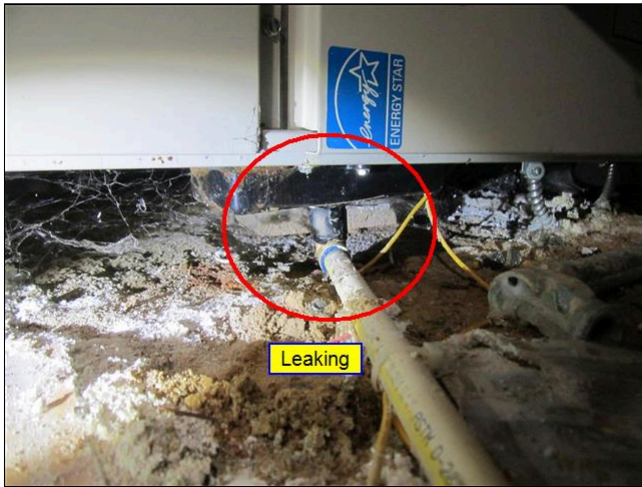
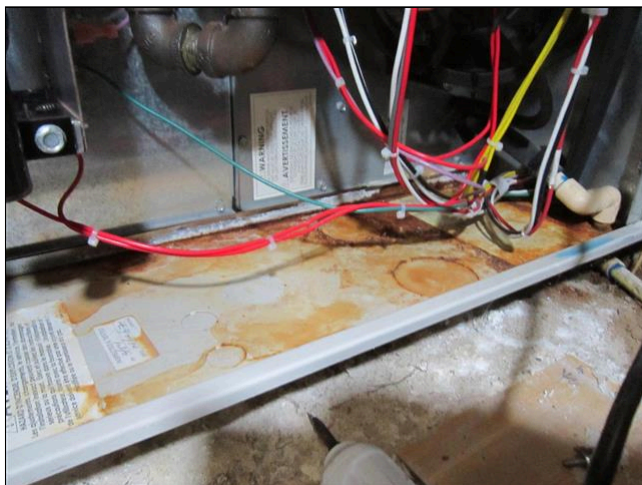
8.0 Item 1(Picture)

The furnace was mfg in 2007 - typical life is 20 yrs. The unit is dirty/rusty/worn and has been leaking at the condensate drain line connection. Repairs are needed. I recommend cleaning/servicing and repairing the furnace as needed by a licensed HVAC contractor.

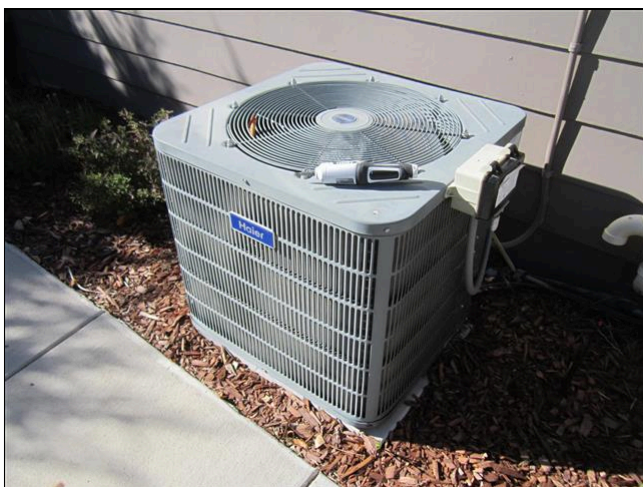
8.8 Item 1(Picture)

(1) The A/C was mfg in 2009 - typical life is 20-25 yrs. The unit is deteriorated and worn. I recommend clean/service by a licensed HVAC contractor.

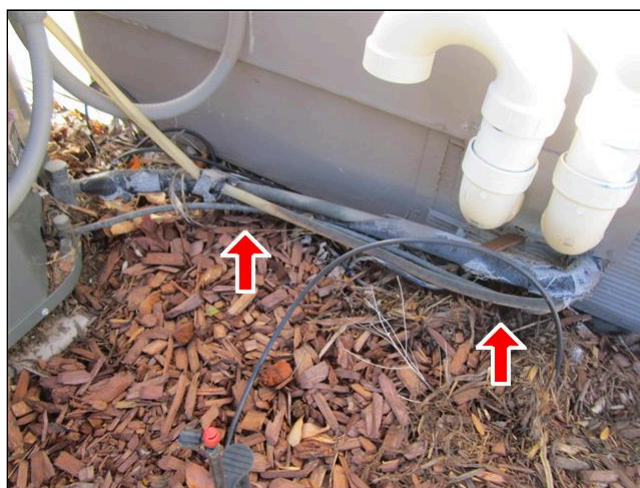
8.8 Item 4(Picture)

(3) The foam sleeve on suction line is deteriorated in area(s) at outside unit. Deteriorated foam on suction line can cause energy loss and condensation. I recommend service or repair as needed.

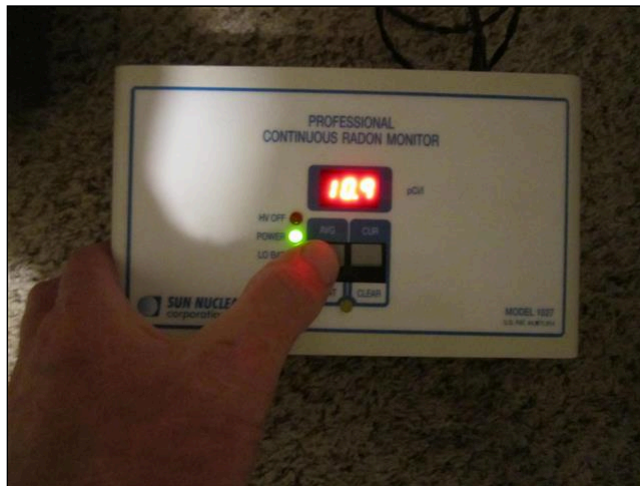
9.3 Item 1(Picture)

A radon test was performed at the above property. The test came back over the EPA max recommended limit of 4.0 at 10.9. Based on this test I recommend a radon mitigation system be installed by a qualified contractor. Radon mitigation systems typically cost between \$1500 and \$3000. I recommend repair as needed by a qualified contractor. The report is located under the "attachments" section of this report

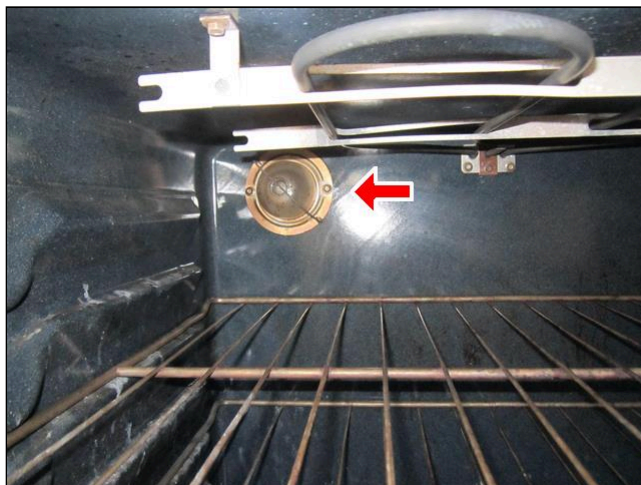
10.1 Item 1(Picture)

The light bulb (in oven) did not work when tested. I recommend repair as needed.

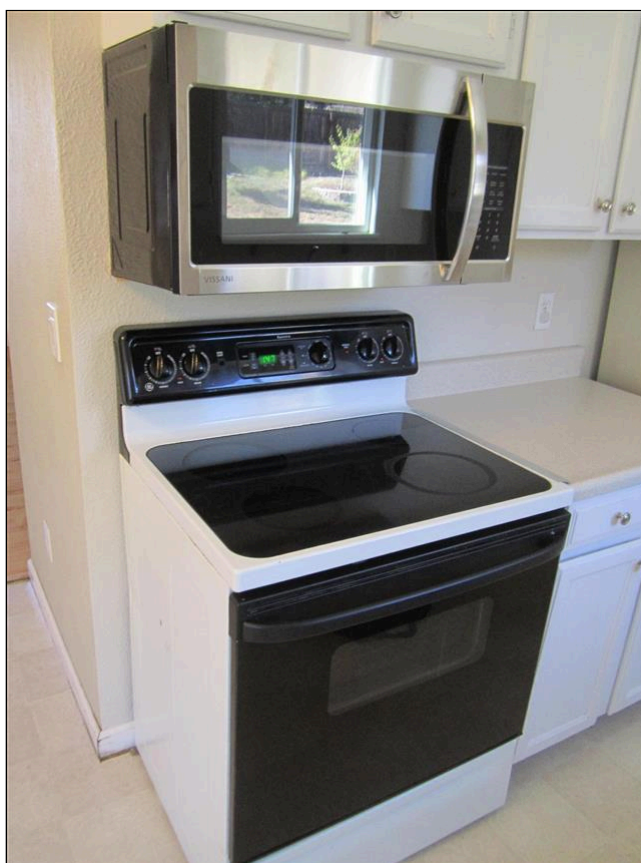
10.5 Item 1(Picture)

The microwave appears to be installed too low to burners and the manufacturers minimum distance requirements should be determined. I recommend further evaluation and repair as needed.
