Commercial and Residential Building Inspection Services

Inspection Report

Property Address:
1234 S. Anywhere Street
Thornton, CO 80233

Date: 3/9/2008	Time: 11:00 AM	Report ID: 28000
Property: 1234 S. Anywhere Street Thornton, CO 80233	Customer: Mr. John Doe Mrs. Jane Doe	Real Estate Professional: Dave Simonson Remax

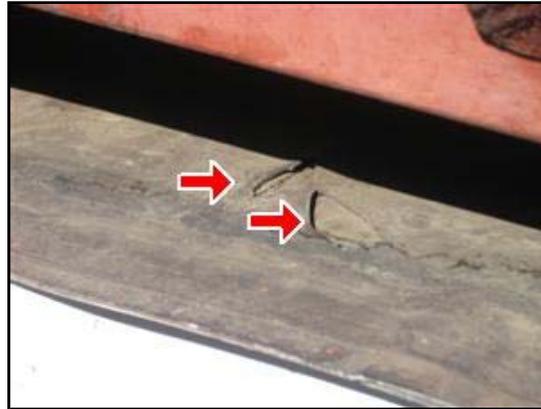
1.0 Picture 1

**1.0** The roof covering is damaged at the Sun Room. It should be replaced as soon as possible. A qualified contractor should inspect and repair as needed.

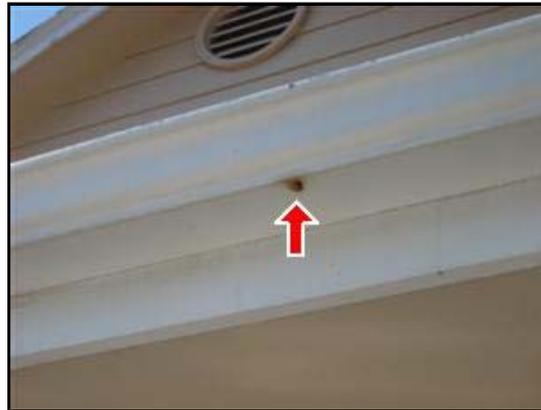
1.3 Picture 1

**1.3** The gutter is damaged and is deteriorated at the front (left of main entry). Gutters that drain poorly or clogged can lead to many costly problems such as deterioration of fascia, soffit or roof edge. It can also cause gutters to pull loose and lead to possible water intrusion. A qualified contractor should inspect and repair as needed.

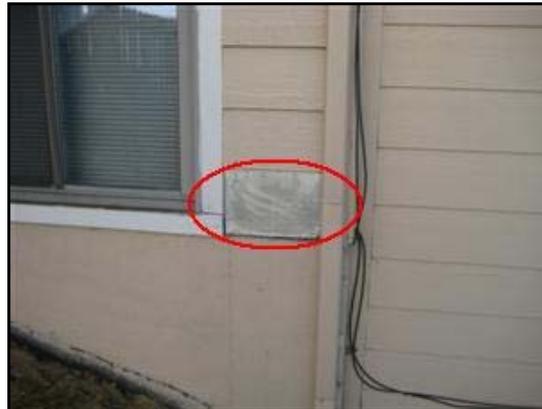
2.0 Picture 1

**2.0 (1)** The Wood siding at the right side (facing front) is missing. Because of the extent of deterioration it is possible for some framing to be deteriorated. A qualified contractor should inspect and repair as needed.

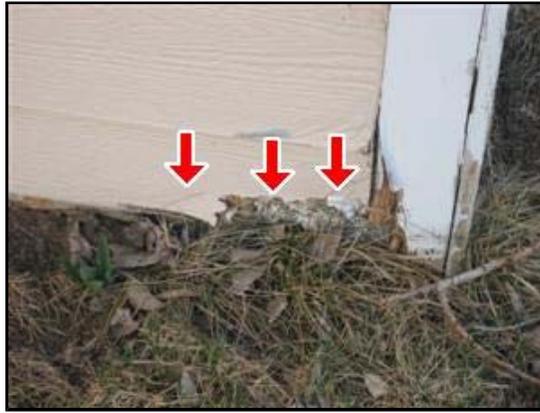
2.0 Picture 2

**(2)** The Wood siding at the right side (facing front) is deteriorated along bottom edge and also is in contact with ground. Because the siding is in contact with ground it is possible for framing to be deteriorated. We did not inspect behind this siding. A qualified contractor should inspect and repair as needed.

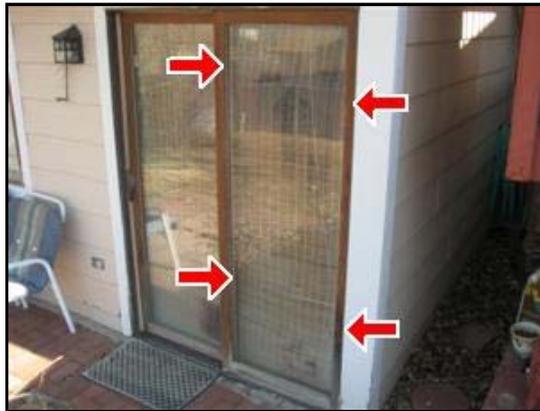
2.1 Picture 1

**2.1** The basement entry door is does not lock and also has a broke glass. A repair or replacement is needed. A qualified contractor should inspect and repair as needed.

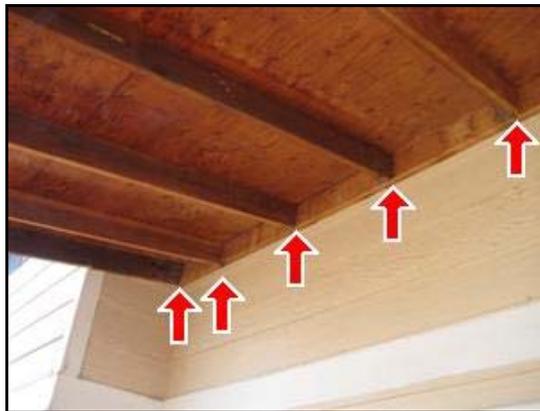
2.3 Picture 1

**2.3** The Patio roof cover was installed improperly at the rear of home. This is for your information. I recommend repair as desired.

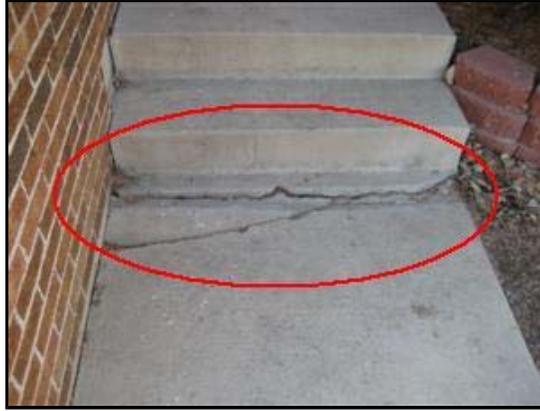
2.4 Picture 1

**(2)** The sidewalk at the right side (facing front) uneven, and can be a tripping hazard and has dropped or settled causing a steep or uneven step. A fall or injury can occur if not corrected and Further erosion or deterioration can occur if not corrected. A qualified contractor should inspect and repair as needed.

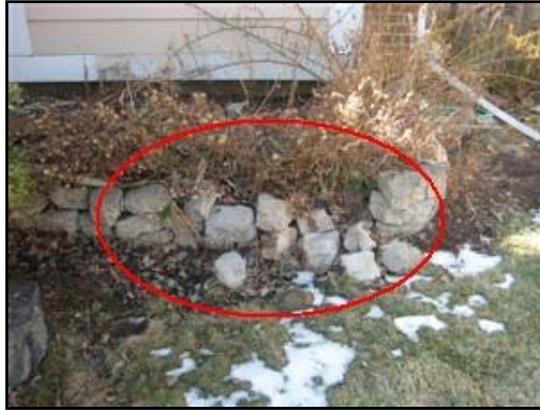
2.4 Picture 2

(3) The stone retaining wall at the front of home is old and deteriorated and shows signs of erosion and a possible drainage problem. This is a maintenance issue and is for your information. I recommend repair as needed.

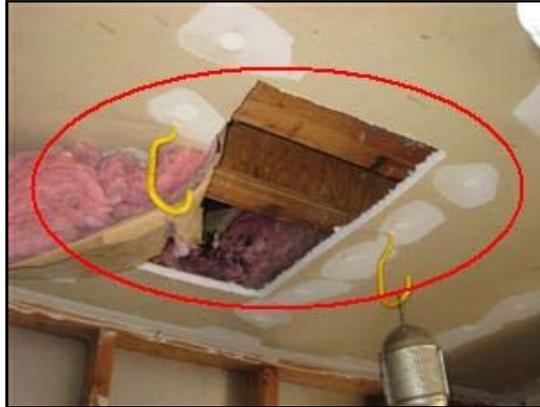
3.0 Picture 1

**3.0** The Drywall on the ceiling is missing in areas at the garage. Repairs are needed. A qualified contractor should inspect and repair as needed A qualified person should repair or replace as needed.

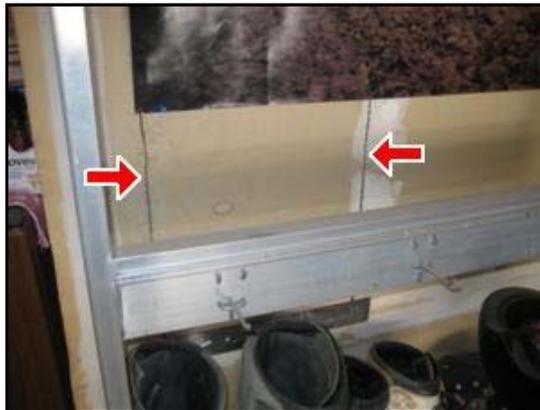
3.1 Picture 1

**3.1** The sheetrock on the wall is loose at the garage. Repairs are needed. A qualified contractor should inspect and repair as needed A qualified person should repair or replace as needed.

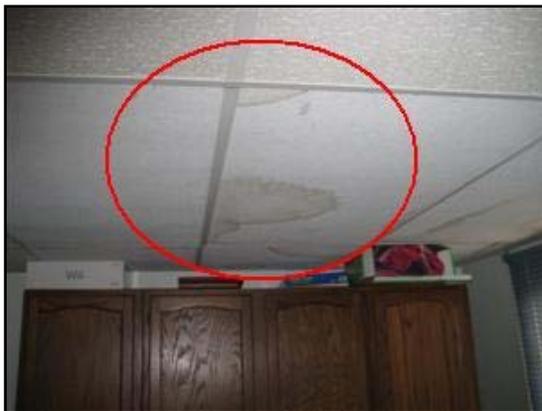
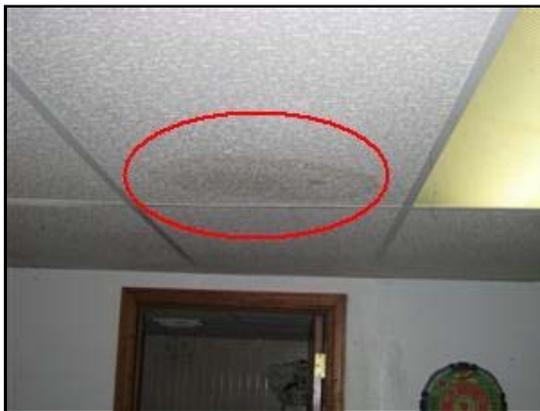
4.0 Picture 1

**4.0** The Ceiling Tile on the ceiling reveals a water stain indicating a leak did or still exists at the Basement. Repairs are needed. A qualified person should repair or replace as needed.

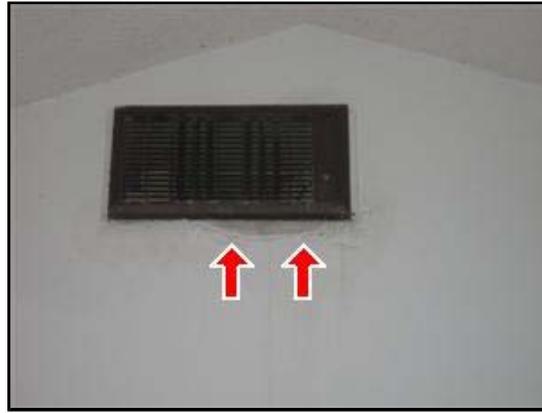
4.1 Picture 1

**4.1 (1)** The sheetrock on the wall is damaged at the Living Room. Repairs are needed. A qualified person should repair or replace as needed.

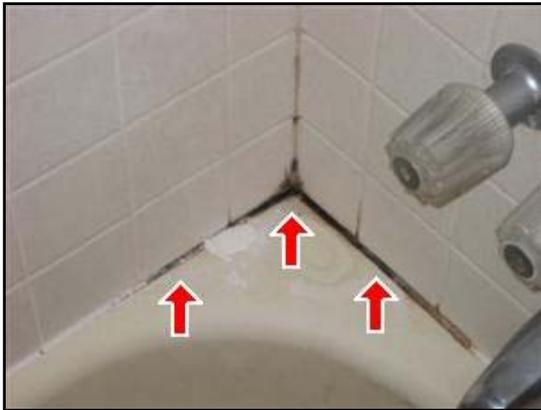
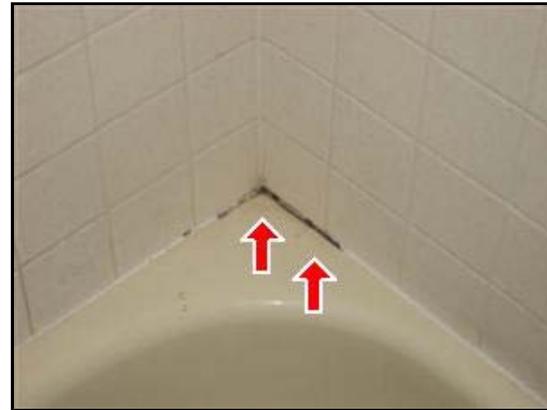
4.1 Picture 2

(2) The Tile surround at bathtub and Tile surround at shower on the wall shows signs of fungi and black mold growth at the hall bath. Repairs are needed. A qualified contractor should inspect and repair as needed.

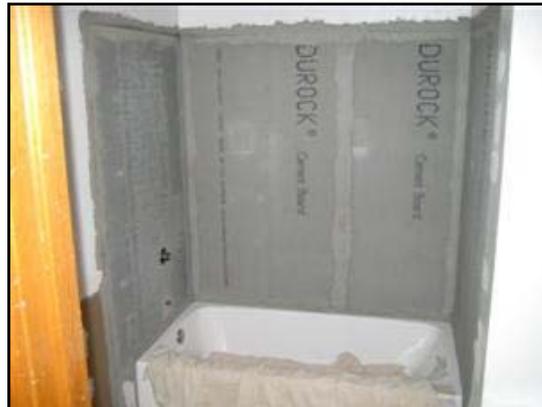
4.1 Picture 4

(4) The walls and floors of the master bath are currently being renovated. Recommend confirming completed work before closing.

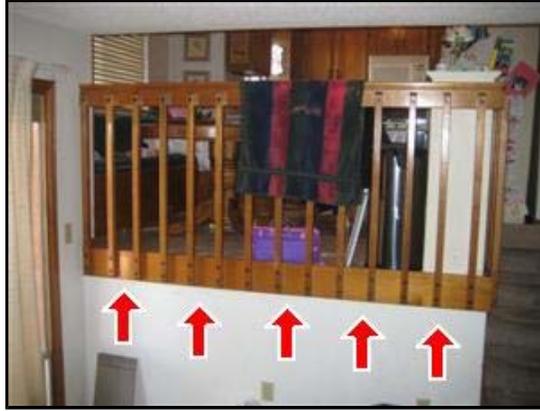
4.3 Picture 1

4.3 The pickets on the guard rail at the upstairs are spaced to far apart for safety. Spacing more than 4 inches apart could allow an adult, child or pet to fall through. A qualified person should repair or replace as needed.

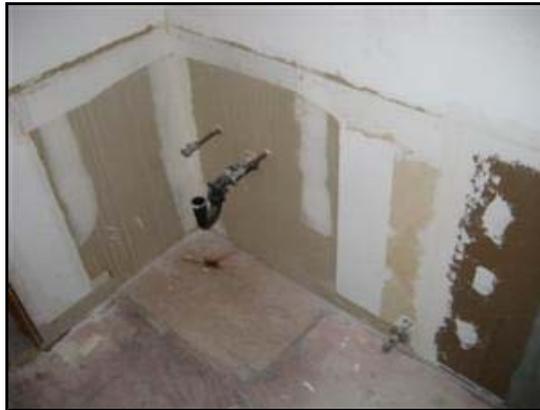
6.1 Picture 1

**6.1 (1)** The master bathroom is currently undergoing complete renovation, it is missing the toilet, sink, and all related faucets. Recommend verifying the completed work before closing.

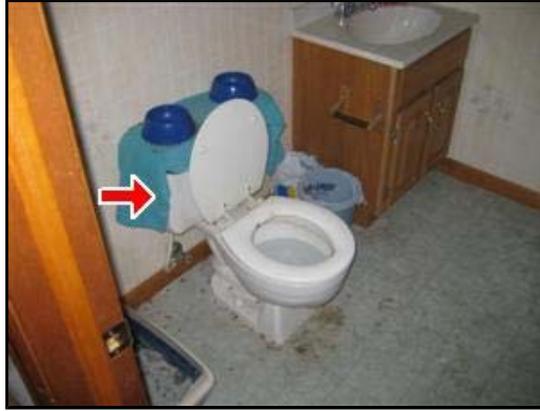
6.1 Picture 2

**(2)** The basement toilet water runs continuously in the tank, repairs are needed.

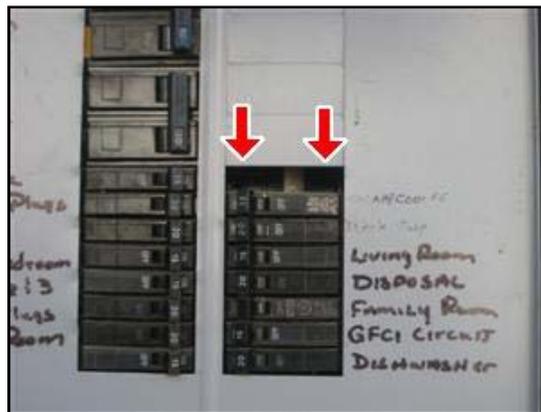
7.1 Picture 1

7.1 The problem(s) discovered in the panel such as knock-outs missing on panel and any other problems that an electrical contractor may discover while performing repairs need correcting. I recommend a licensed electrical contractor inspect further and correct as needed.

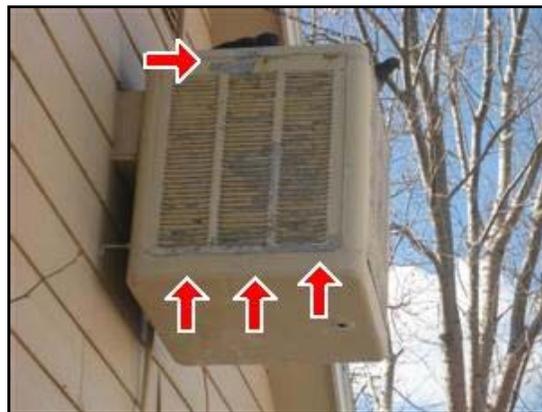
8.8 Picture 1

**8.8** The exterior swamp cooler or evaporative cooler is rusted and peeling paint, recommend paint and repair.

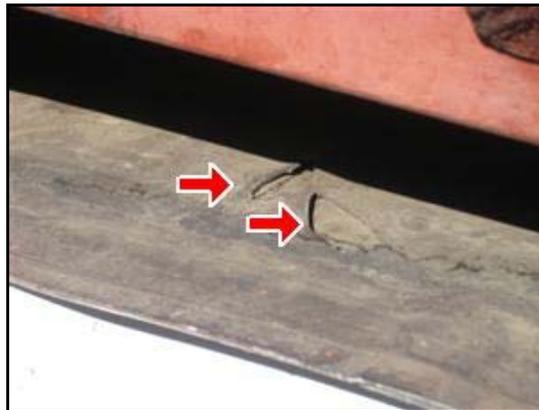
1.0 Picture 1

The roof covering is damaged at the Sun Room. It should be replaced as soon as possible. A qualified contractor should inspect and repair as needed.

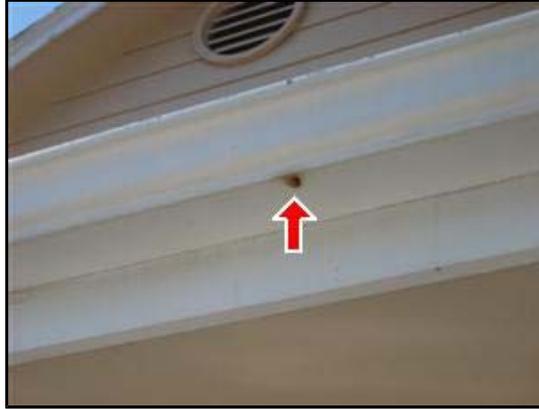
1.3 Picture 1

The gutter is damaged and is deteriorated at the front (left of main entry). Gutters that drain poorly or clogged can lead to many costly problems such as deterioration of fascia, soffit or roof edge. It can also cause gutters to pull loose and lead to possible water intrusion. A qualified contractor should inspect and repair as needed.

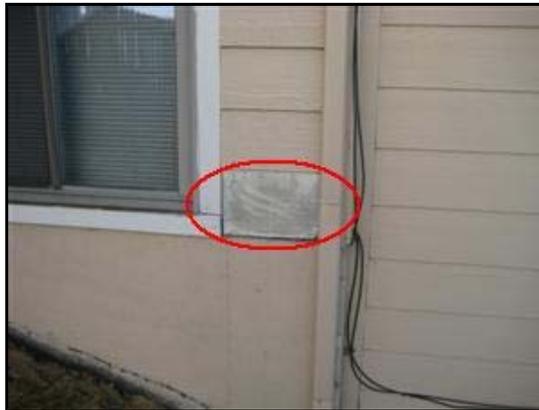
2.0 Picture 1

(1) The Wood siding at the right side (facing front) is missing. Because of the extent of deterioration it is possible for some framing to be deteriorated. A qualified contractor should inspect and repair as needed.

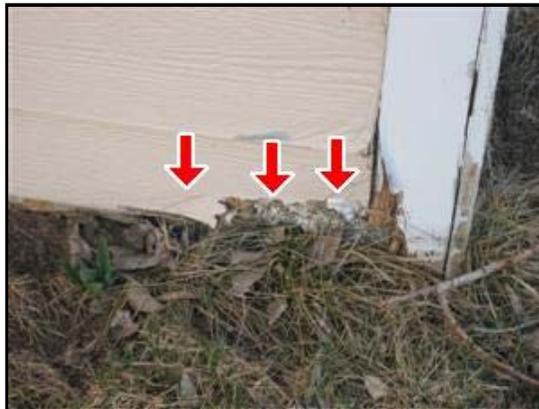
2.0 Picture 2

(2) The Wood siding at the right side (facing front) is deteriorated along bottom edge and also is in contact with ground. Because the siding is in contact with ground it is possible for framing to be deteriorated. We did not inspect behind this siding. A qualified contractor should inspect and repair as needed.

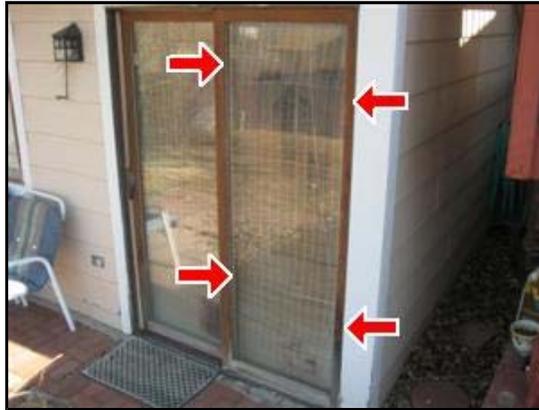
2.1 Picture 1

The basement entry door does not lock and also has a broken glass. A repair or replacement is needed. A qualified contractor should inspect and repair as needed.

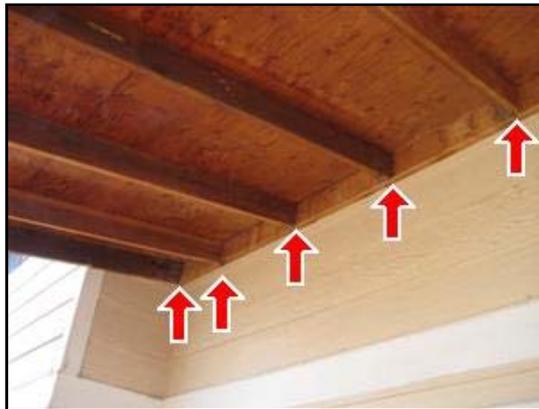
2.3 Picture 1

The patio roof cover was installed improperly at the rear of home. This is for your information. I recommend repair as desired.

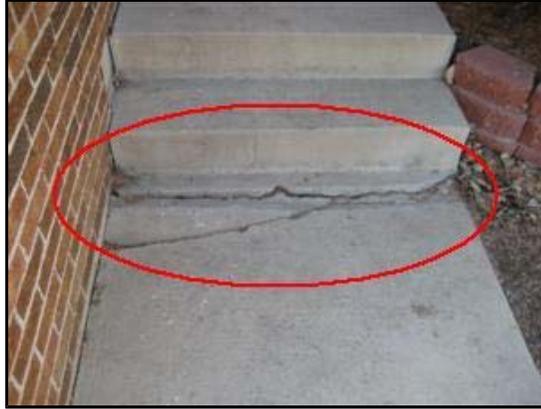
2.4 Picture 1

(2) The sidewalk at the right side (facing front) uneven, and can be a tripping hazard and has dropped or settled causing a steep or uneven step. A fall or injury can occur if not corrected and Further erosion or deterioration can occur if not corrected. A qualified contractor should inspect and repair as needed.

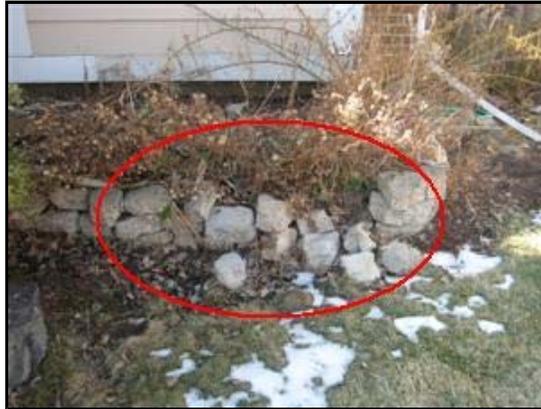
2.4 Picture 2

(3) The stone retaining wall at the front of home is old and deteriorated and shows signs of erosion and a possible drainage problem. This is a maintenance issue and is for your information. I recommend repair as needed.

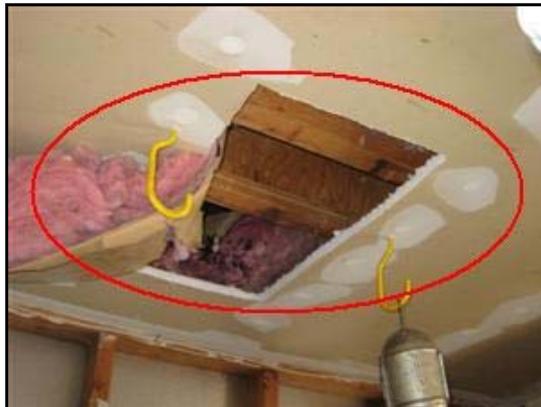
3.0 Picture 1

The Drywall on the ceiling is missing in areas at the garage. Repairs are needed. A qualified contractor should inspect and repair as needed A qualified person should repair or replace as needed.

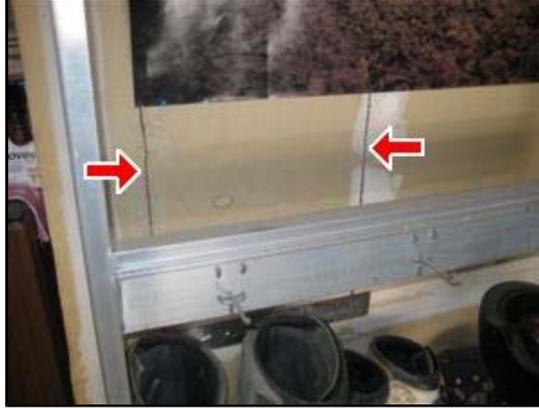
3.1 Picture 1

- 🏠 The sheetrock on the wall is loose at the garage. Repairs are needed. A qualified contractor should inspect and repair as needed. A qualified person should repair or replace as needed.

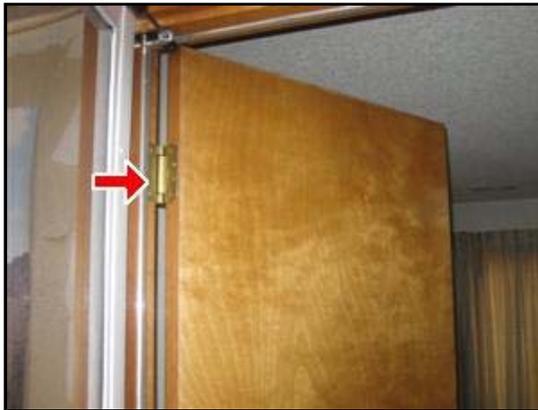
3.4 Picture 1

- 🏠 The self closing device is damaged and non functional, recommend repair

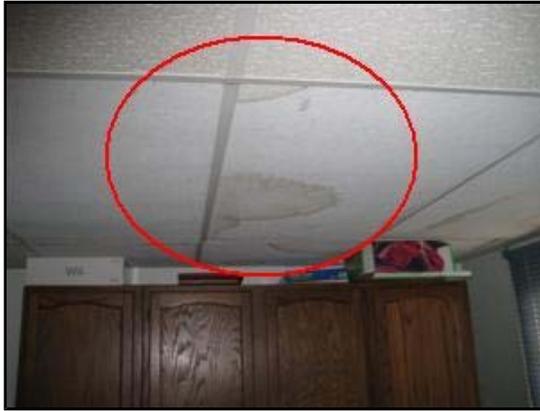
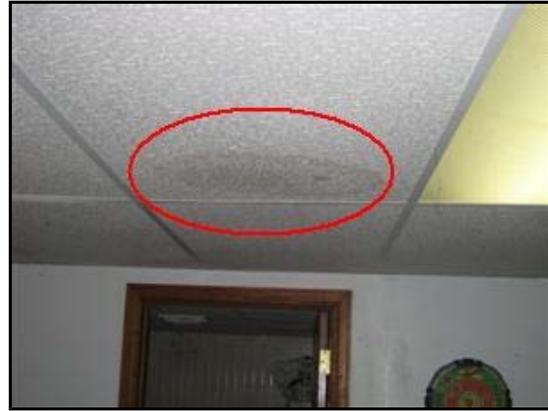
4.0 Picture 1

- 🏠 The Ceiling Tile on the ceiling reveals a water stain indicating a leak did or still exists at the Basement. Repairs are needed. A qualified person should repair or replace as needed.

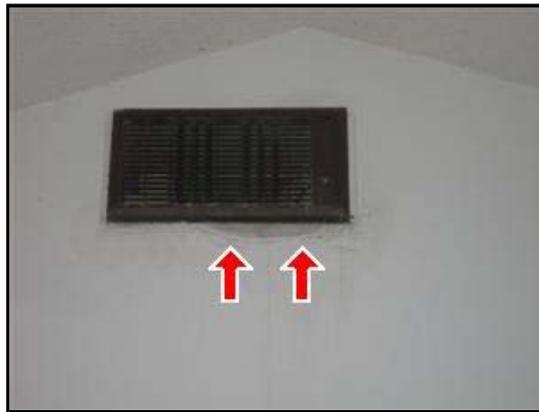
4.1 Picture 1

(1) The sheetrock on the wall is damaged at the Living Room. Repairs are needed. A qualified person should repair or replace as needed.

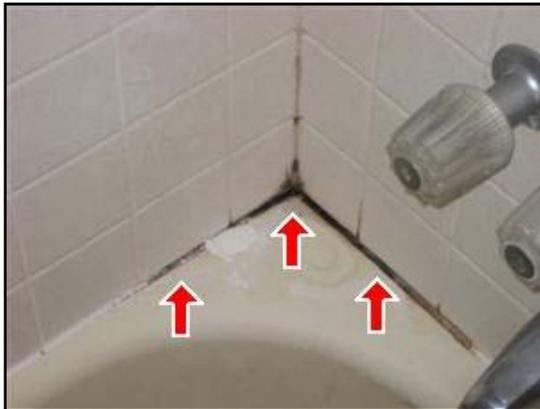
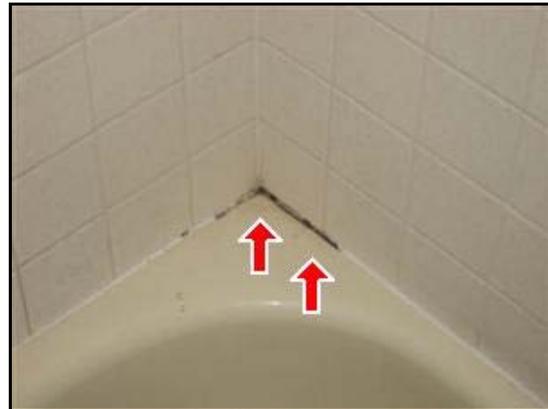
4.1 Picture 2

(2) The Tile surround at bathtub and Tile surround at shower on the wall shows signs of fungi and black mold growth at the hall bath. Repairs are needed. A qualified contractor should inspect and repair as needed.

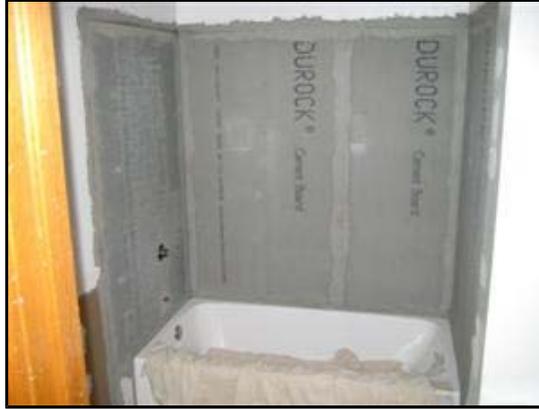
4.1 Picture 4

(4) The walls and floors of the master bath are currently being renovated. Recommend confirming completed work before closing.

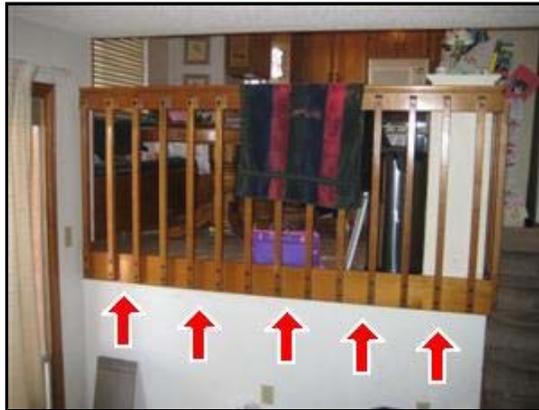
4.3 Picture 1

The pickets on the guard rail at the upstairs are spaced to far apart for safety. Spacing more than 4 inches apart could allow an adult, child or pet to fall through. A qualified person should repair or replace as needed.

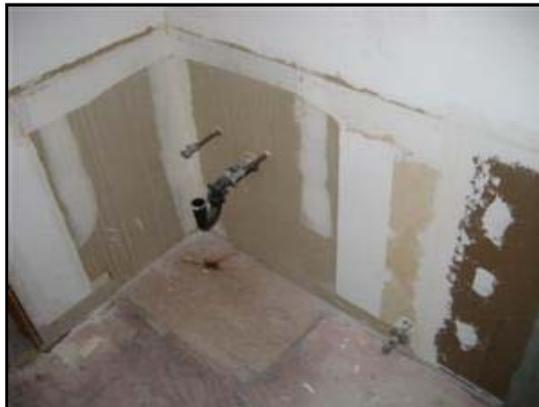
6.1 Picture 1

(1) The master bathroom is currently undergoing complete renovation, it is missing the toilet, sink, and all related faucets. Recommend verifying the completed work before closing.

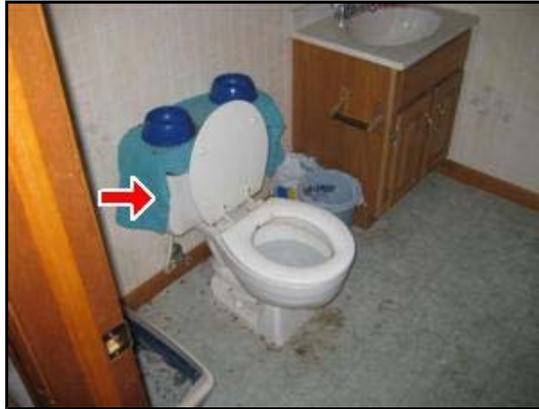
6.1 Picture 2

(2) The basement toilet water runs continuously in the tank, repairs are needed.

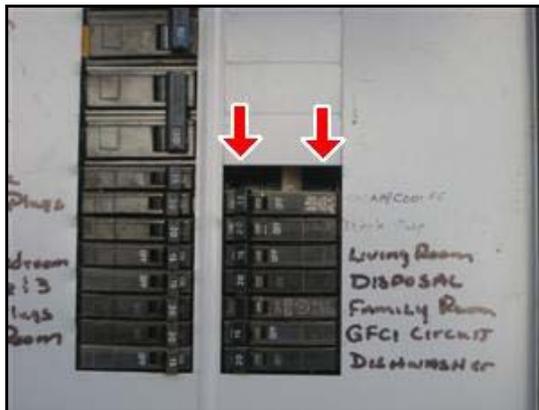
7.1 Picture 1

The problem(s) discovered in the panel such as knock-outs missing on panel and any other problems that an electrical contractor may discover while performing repairs need correcting. I recommend a licensed electrical contractor inspect further and correct as needed.

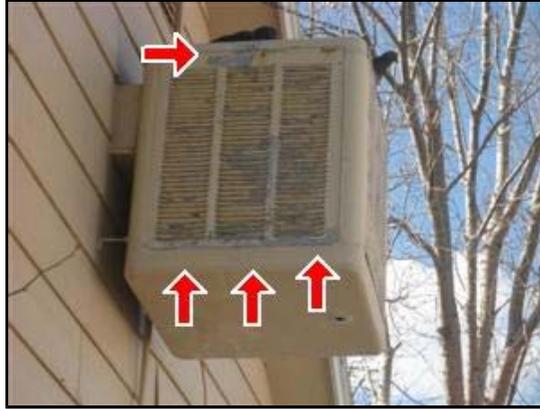
8.8 Picture 1

The exterior swamp cooler or evaporative cooler is rusted and peeling paint, recommend paint and repair.
